THE HAITI EARTHQUAKE OF 12 JANUARY 2010

A FIELD REPORT BY EEFIT

Edmund Booth, Edmund Booth Consulting Engineer.

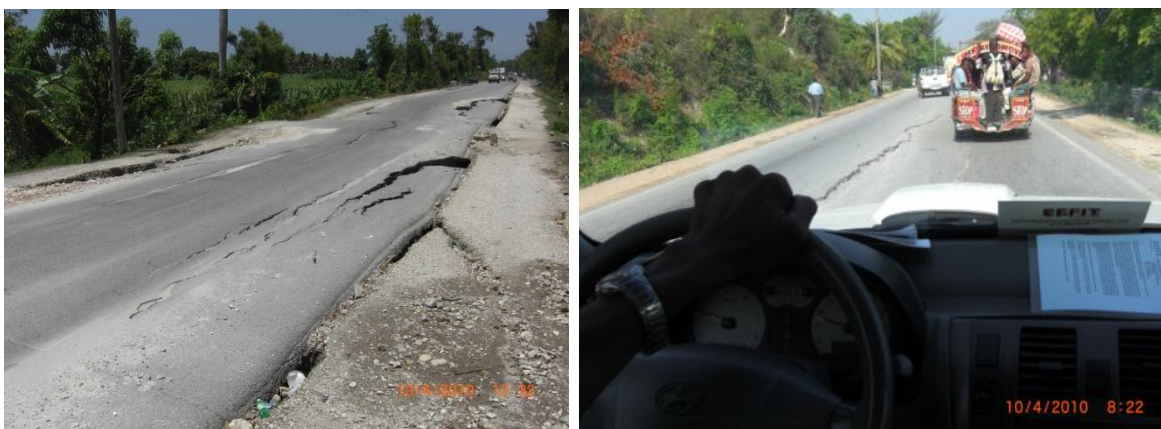
Failures of the road surface were noted by the EEFIT team when travelling between Léogane and L'acul (Figure 3.10). Initially, these were thought to be evidence of a surface fault expression. However, other explanations are possible, and the GEER report (Rathje *et al* 2010) specifically rejects this possibility. The failures may have been due to the slope failure of the sides of the embankment leading to longitudinal cracks on the road surface.

Figure 3.10: Road failure at two locations of the road between Léogane and L'acul

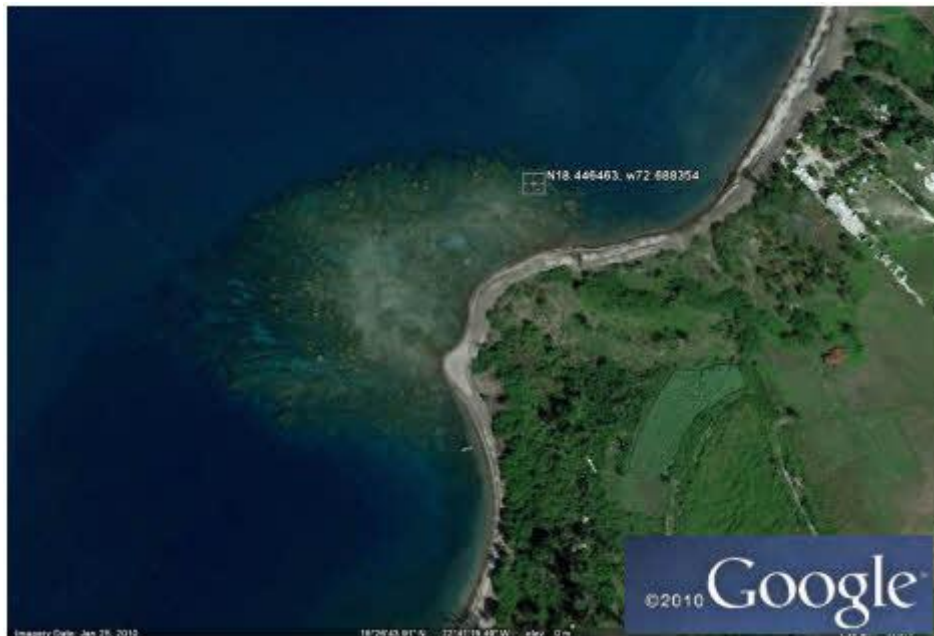
At the site near L'acul, coastal uplift was identified based on aerial images as shown in Figure 3.11. The local residents confirmed that the corals at this site were not exposed prior to the 12 January earthquake. However in Figures 3.12 and 3.13 the exposed corals can be clearly seen. The close up view of the coral in Figure 3.13 indicates that the coral has died as it was exposed to direct sunlight and dried following the coastal uplift caused by the earthquake.

Figure 3.11: An aerial view of the coastal uplift near L'acul

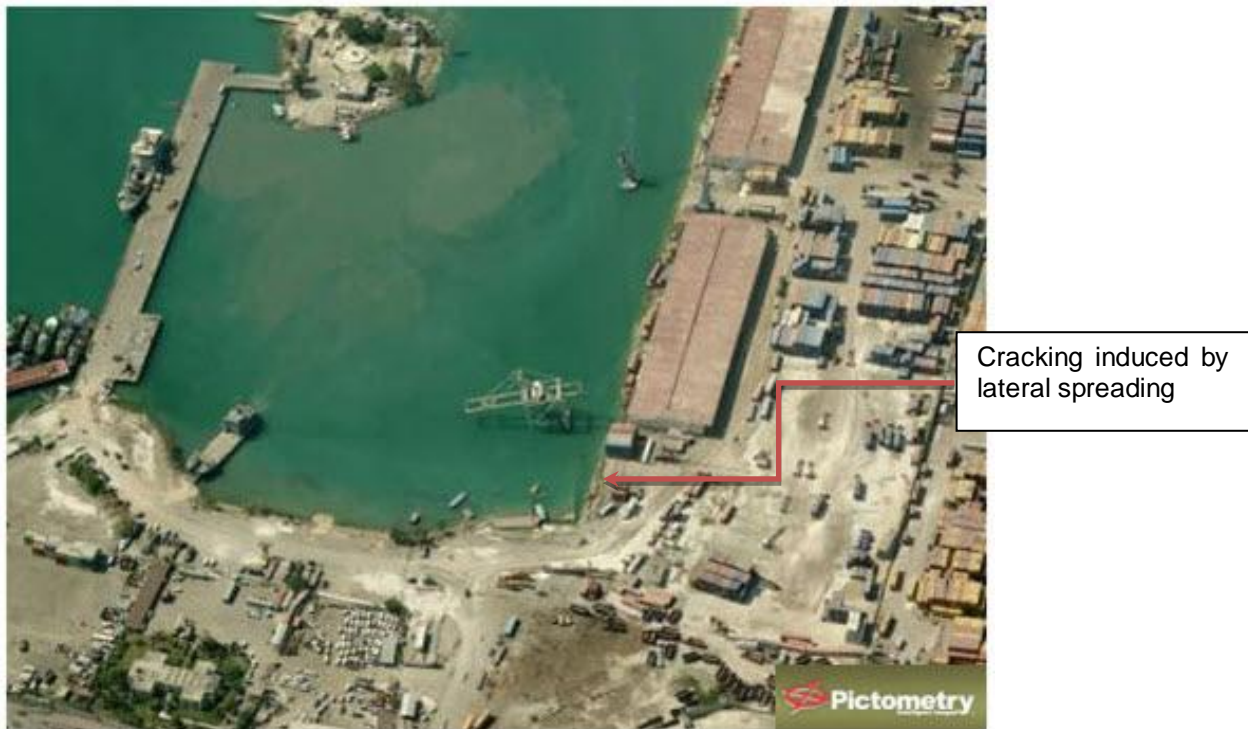
In Figure 4.4 a Pictometry image of the north wharf is presented. The collapsed north wharf is clearly seen in this Figure. Also the damage to the gantry crane is clearly seen. These correspond to the red rectangular area marked in Figure 4.2 in which the satellite image showed the same damage. Comparing Figs. 4.2 and 4.4 it can be seen that the Pictometry images offer much higher resolution and therefore increase our ability to identify damage based on remote imagery. In fact in Figure 4.4 some of the lateral spreading that occurred at this site can also be seen with extensive cracking of the ground. Similarly the island that houses the harbour master's office can also be seen at the top of this Figure. However, it is quite difficult to see the settlements suffered by the island or damage to the bridge connecting the island to the south pier or to the buildings. In Figure 4.5 a Pictometry image of the mobile crane and container storage area is shown. Large silos for bulk material storage can also be seen in this image. Although there was liquefaction induced lateral spreading that occurred close to the coastline (far left of Figure 4.5) there was no damage to the silo structures or their foundations.

Figure 4.4: A Pictometry image of the overview of the collapsed north wharf and the crane (February 2010)

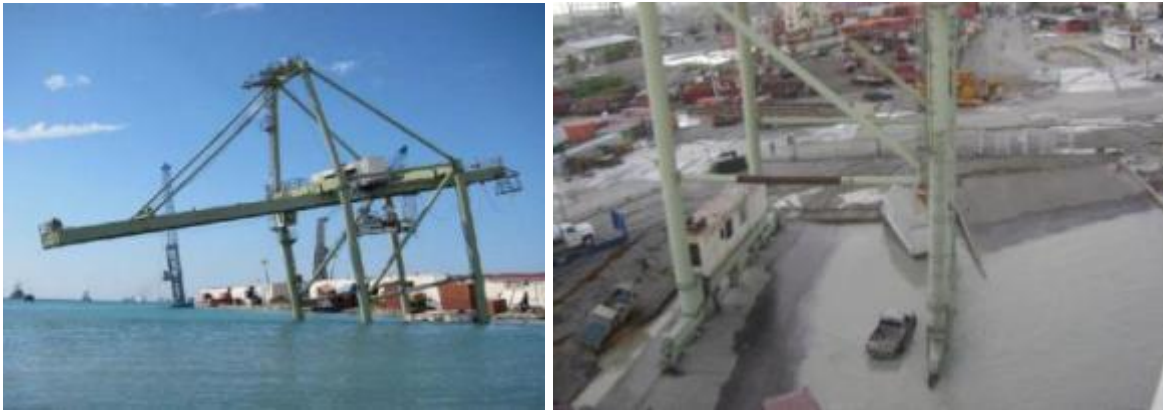
Figure 4.6: Collapsed gantry crane
(Photos: Courtesy of Prof El-Gamal, UC San Diego)

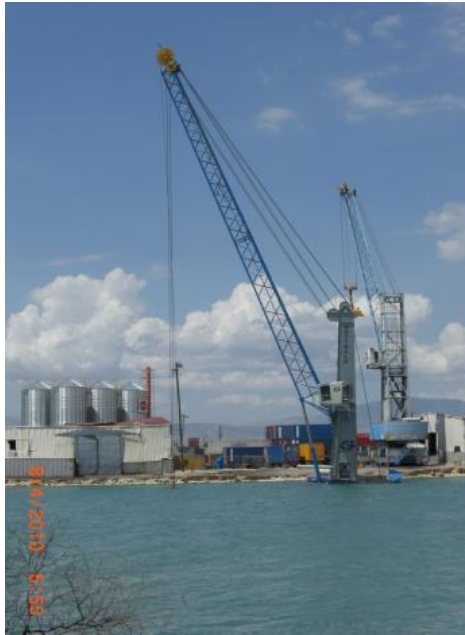
In addition to the collapsed gantry crane, damage was also observed to a second mobile crane. This crane was still present at the time of EEFIT visit. This mobile crane was visible in the satellite and Pictometry images presented earlier. In Figure 4.7, a view of the damaged mobile crane is presented. The tower part of the crane has rotated as the foundations below have allowed settlement and rotation presumably following soil liquefaction. As a result of the damage to the crane structures the port was unable to off load any of the relief aid that was arriving. Only ships with self-contained cranes were seen bringing in building materials, food grains and other relief at the time of the EEFIT visit.

Figure 4.7: Damaged mobile crane at the time of the EEFIT visit

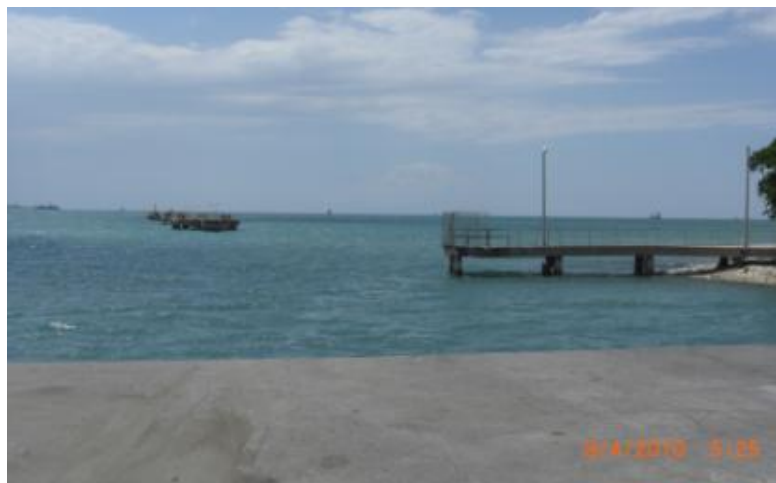
In Figure 4.8 a view of the collapsed sections of south pier are shown. These sections can be seen in the satellite image of Figure 4.2, identified by a red elliptical ring. In Figure 4.8 it can be seen that pile caps supporting the ends of the sections have remained while the bridging deck sections have collapsed. This could have been due to excessive settlement of the piles causing the deck sections to dislodge and collapse.

Figure 4.8: Collapsed sections of the south pier

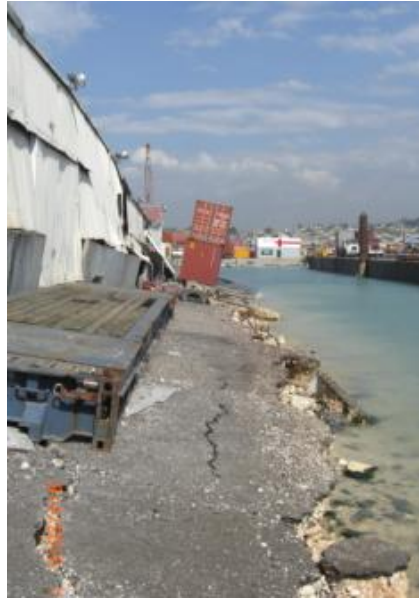
As was evident from the aerial images of Figures 4.2 and 4.4, the entire north wharf Section has completely collapsed. A view of the collapsed Section is seen in Figure 4.11. The reason for this collapse was the extensive soil liquefaction observed at this site. Liquefaction and lateral spreading may have caused the foundations supporting the wharf to settle and rotate leading to the complete collapse of the wharf structure.

Figure 4.11: Collapsed Section of the north wharf

The storage facility next to the wharf also suffered extensive damage as seen in Figure 4.11. The foundations of the supporting columns of the storage facility suffered extensive settlement following liquefaction, as discussed further in Section 7.4.

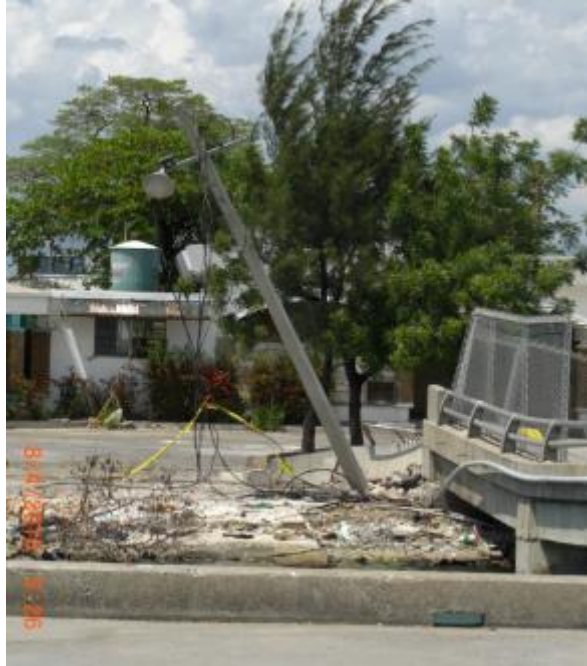
Soil liquefaction and subsequent lateral spreading was clearly evident at the island. The electricity poles have clearly suffered severe rotation owing to the lateral spreading of the ground. This is shown in Figure 4.13.

Figure 4.13: Lateral spreading causes an electricity pole to rotate

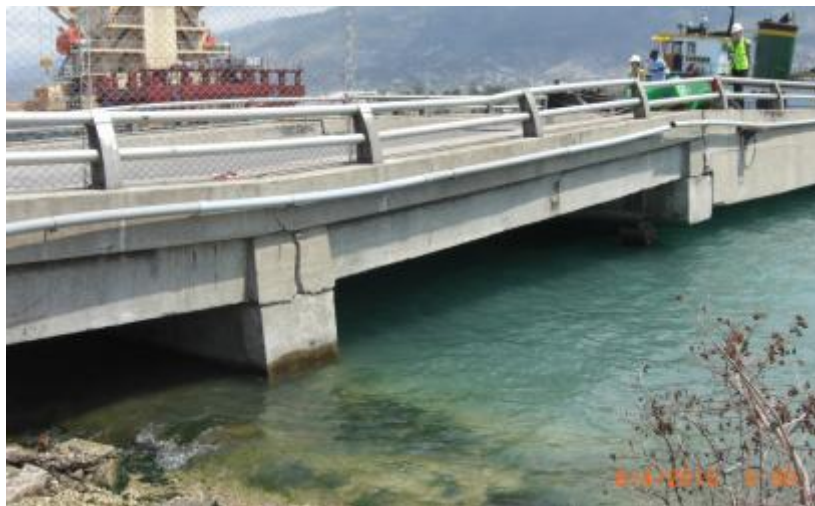
The settlement of island was noted to be nearly 1.0 m relative to the south pier. However the pile foundations supporting the connecting bridge have settled even further. This has led to severe distress in the deck sections connecting to the pier head which have cracked and allowed a hinge to be formed. The bridge seemed to have self-articulated itself to accommodate the settlement of the piers as shown in Figure 4.14.

Figure 4.14: Settlement of pile foundations causes self-articulation of the connecting bridge

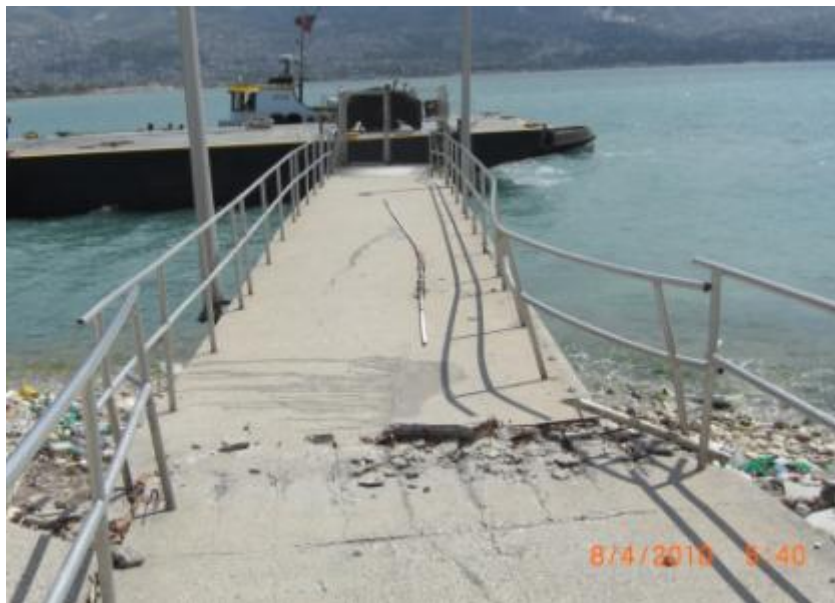
A pile supported wharf structure was present at the island to allow the mooring of boats and pontoons. This wharf structure has suffered severe damage as shown in Figure 4.15. A view of the underside of this wharf is shown in Figure 4.16 that shows the damage to the piles supporting the wharf.

Figure 4.15: Severe damage to a pile supported wharf structure

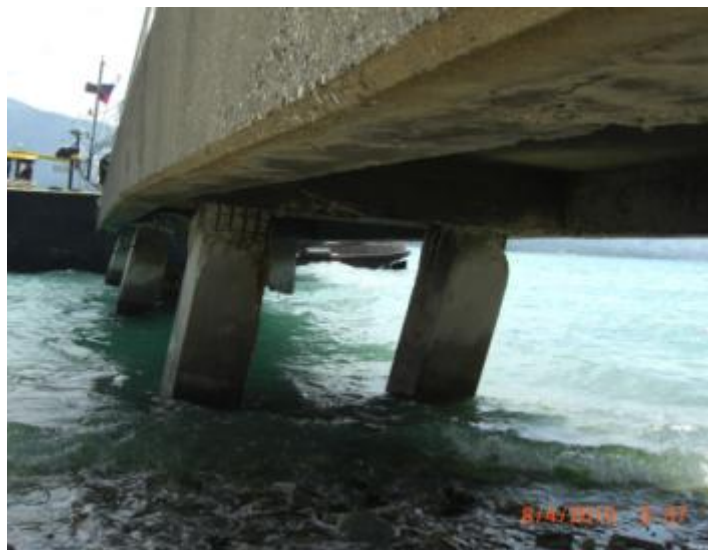
The piles supporting the wharf were passing through the liquefied and laterally spreading soil below that is moving in a westerly, seawards direction, away from the west end of the settling island and transversely to the bridge. This has led to a classical failure mechanism with plastic hinges forming at the pile heads. In Figure 4.17, the concrete at the pile heads cracked revealing the reinforcement and indicating loss of moment fixity and clear formation of a plastic hinges. This type of failure mechanism was observed earlier in dynamic centrifuge tests and was proposed as one of the possible failure mechanisms for piles in laterally spreading liquefied soils as shown in Figure 4.17 (Madabhushi *et al*, 2009).

Figure 4.16: A view of the underside of the wharf showing the damaged piles

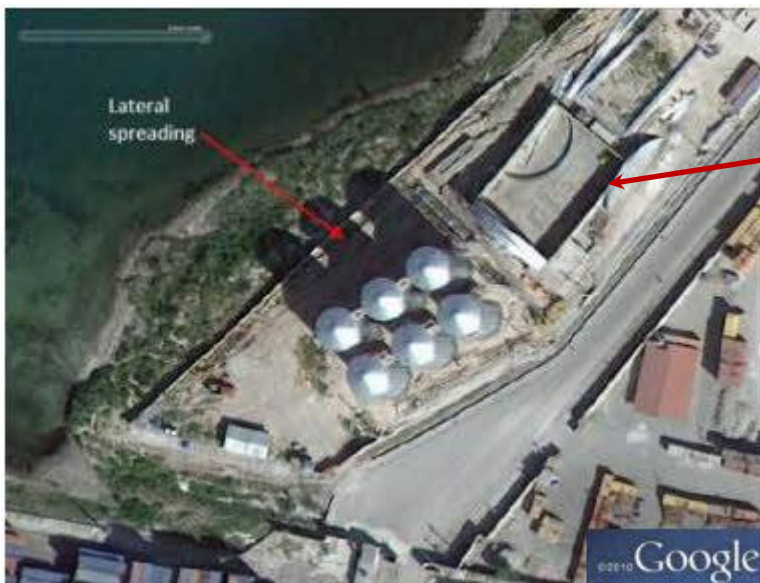
Liquefaction induced lateral spreading was observed at other locations in the port area. There was extensive lateral spreading observed behind the silo structures adjacent to the container storage facility within the port area. These silos are identified in the image shown in Figure 4.18. In this Figure the lateral spreading is clearly identified along the boundary wall. A view of the silo structures from ground is presented in Figure 4.19. The silos themselves were undamaged by the earthquake, despite the lateral spreading. However, the building adjacent to the silos had a collapsed roof and the supporting wall closest to the shoreline, seemed to have moved with laterally spreading soil causing the roof to collapse.

Building with collapsed roof and wall that moved laterally spreading soil

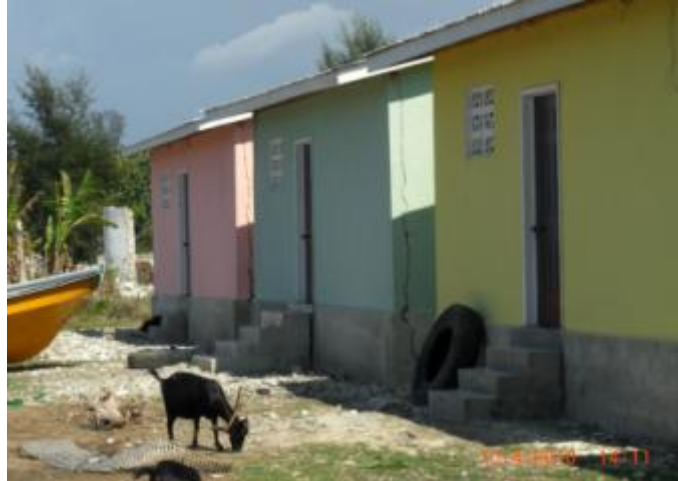
The EEFIT team visited a group of new houses constructed close to the shoreline. It is thought that these were constructed by an NGO. The houses showed extensive cracking as seen in Figure 4.21. These cracks have been induced by the laterally spreading ground following liquefaction although the construction quality and materials used seemed to be of relatively good quality.

Figure 4.21: Damaged houses displaying extensive cracking

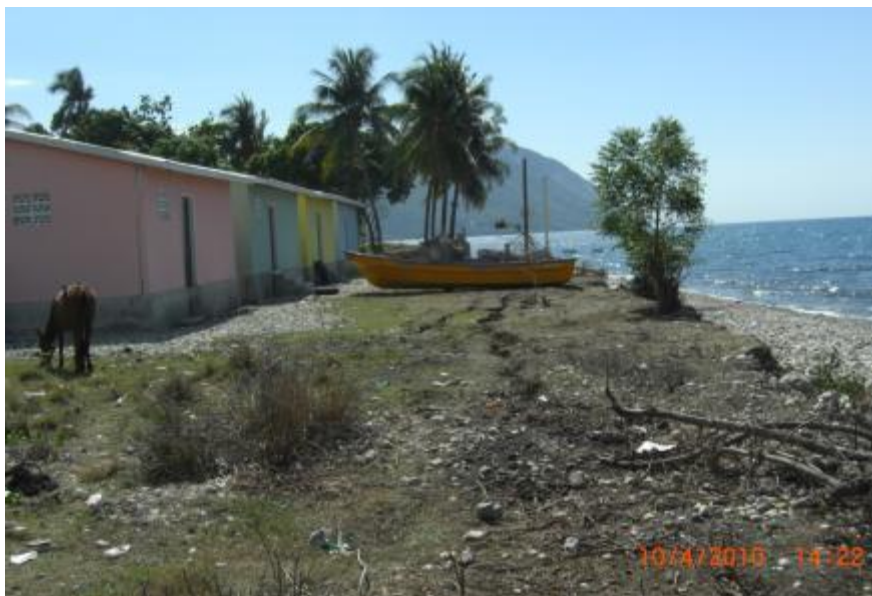
At this site the surface layers appeared to be clayey silt. Long tension cracks were visible viewed from the ground close to the buildings as seen in Figure 4.22. It appeared that this surface layer has spread laterally over a liquefied sandy layer below. As the surface layer is clayey silt with low permeability, it is likely that it was able to hold the excess pore pressures generated in the sandy layers below for an extended period, giving rise to a greater lateral spread. Buildings supported on this soil also move laterally and suffered damage as explained earlier. In Figure 4.23 a close-up view of the steps that got separated from the buildings is presented to confirm the lateral spreading of the ground.

Figure 4.22: Evidence of lateral spreading close to the buildings

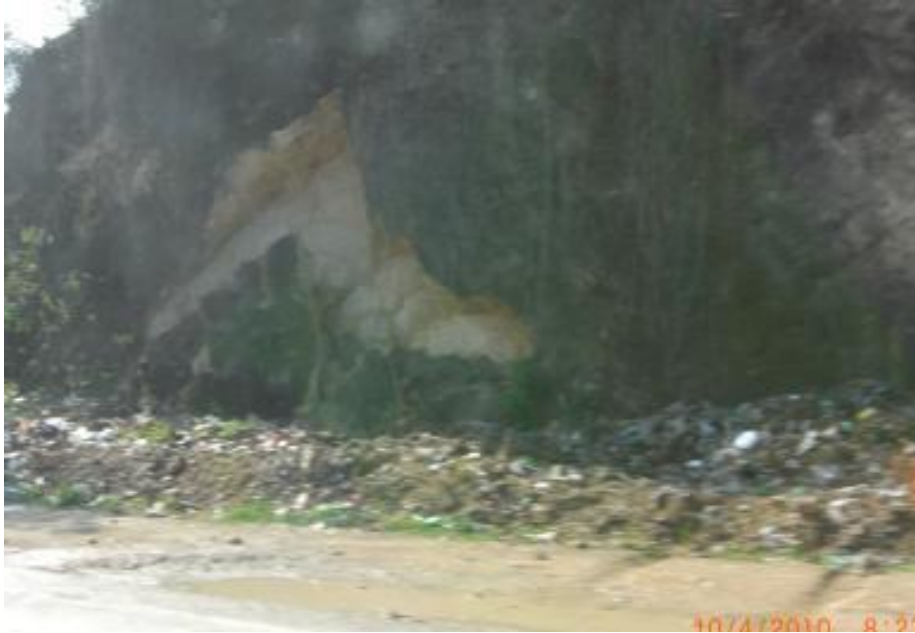
Landslides and in general failure of slopes were observed in the road cuttings next to the highway leading from Port-au-Prince to Léogane. An example of a slip failure of the road cutting is presented in Figure 5.2. This slip was caused by the earthquake as evident from the fresh rock visible in this Figure. The sandstone rock forming the slope of the cuttings seemed to be heavily weathered and fractured, thereby making it susceptible to failure under earthquake loading. However the quantity of material involved in these kinds of slips was fairly small and the highways were able to operate following the clear up of the debris material. There were many examples of these kinds of rock slips.

Figure 5.2: Slip failure in a cutting next to the highway

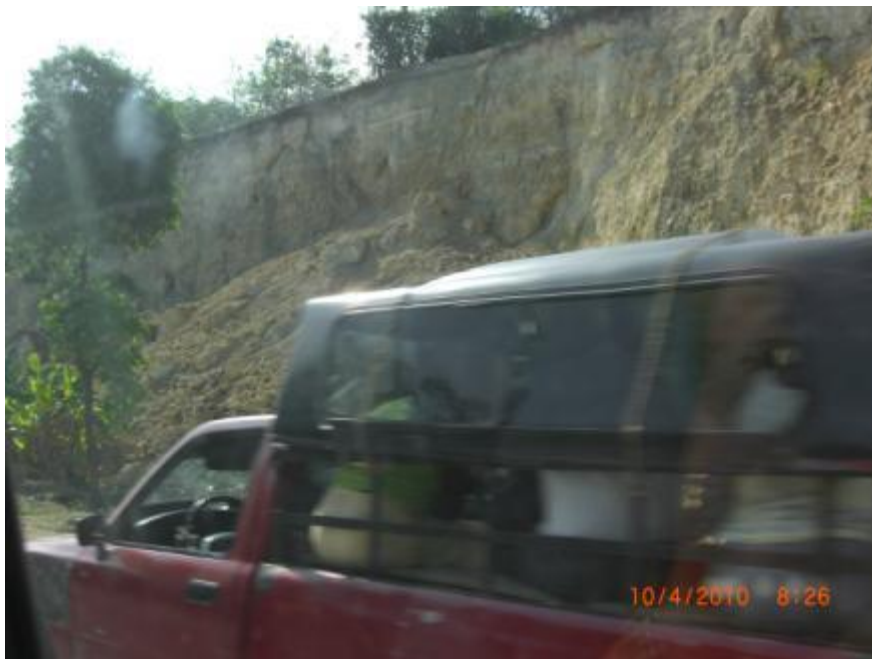
Figure 5.3: A substantial landslide next to the highway

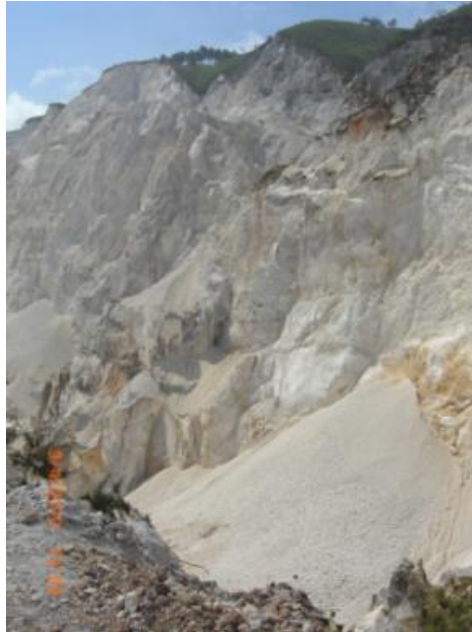
30 to 45 meters. Localised landslides were observed within the sand quarry following the earthquake although no wholesale movement of the slopes was observed. There are many such slopes in and around Port-au-Prince. The slopes formed by these sand quarries can induce landslides particularly during the hurricane season. Each of these sand quarries should be carefully monitored for movements based on their proximity to buildings and ensure slope stabilisation measures are carried out, if required.

Figure 5.6: Localised landslides within the sand quarry

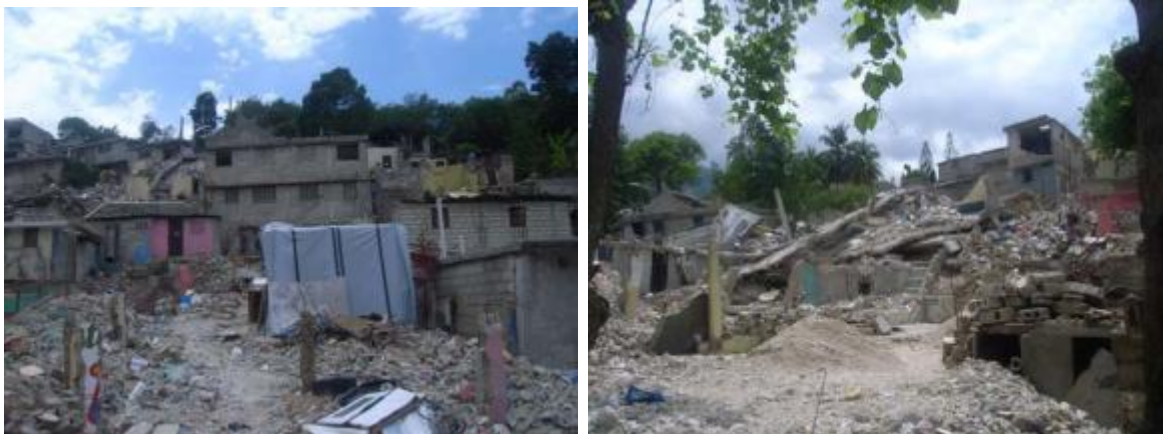
Figure 6.19: Heavily damaged buildings in the area immediately to the south of location 17.

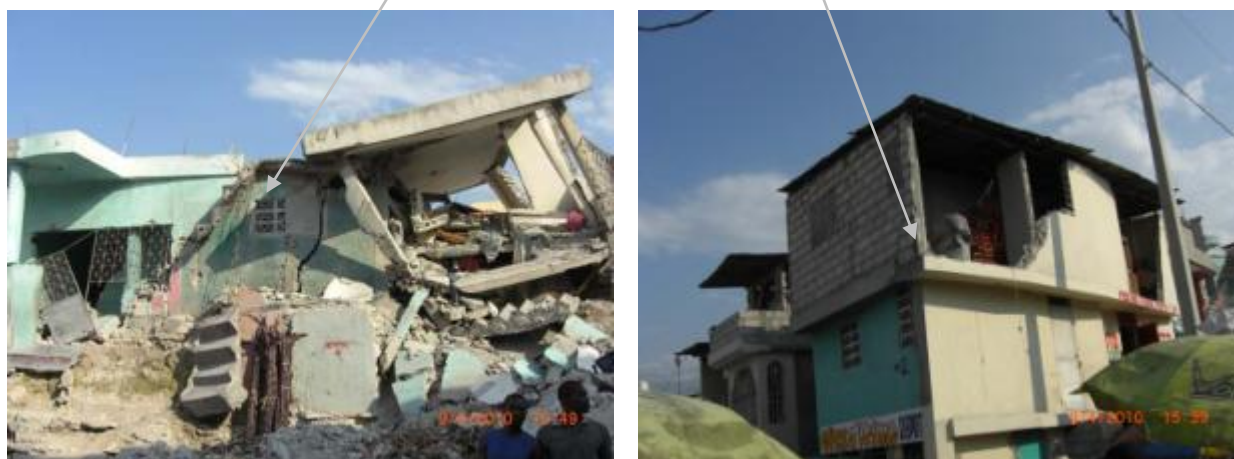
Figure 6.24: (left) Completely collapsed building. Both GEO-CAN and Pictometry interpretations considered this building to be two separate buildings. (right) Heavy damage to infill wall on the third storey. This type of damage often cannot be seen from above.

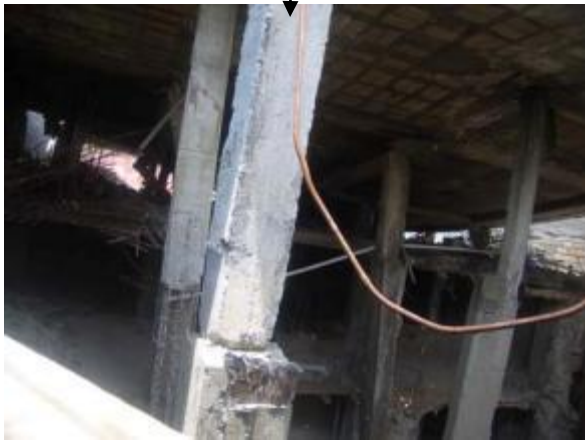
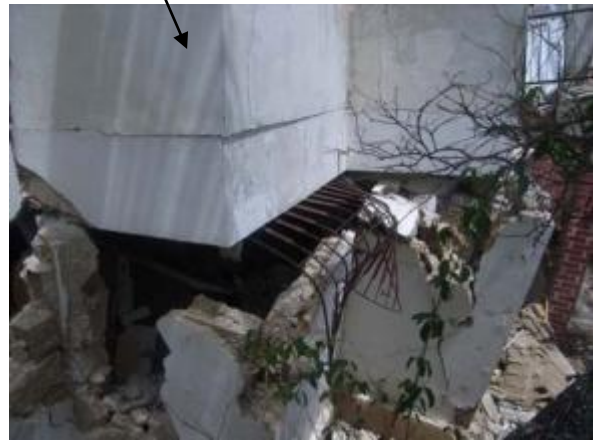
Figure 6.31: (left) Building under construction that suffered heavy damage, (right) soft storey building. Both buildings were assigned D5 by EEFIT, D5 and D4 by Pictometry, but were missed by GEO-CAN.

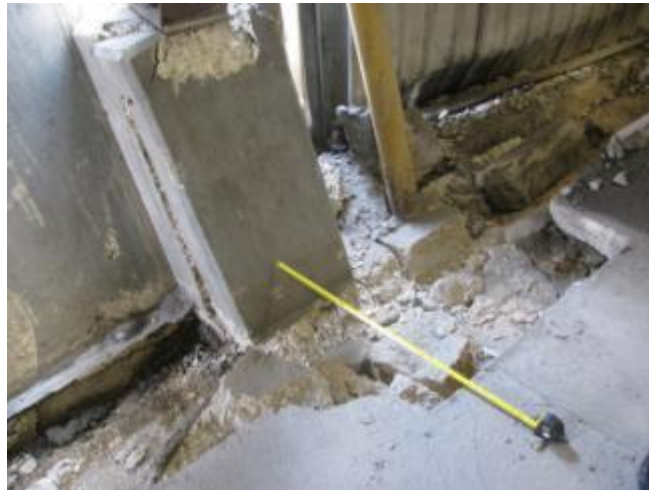
Figure 7.3: Lateral and vertical displacement of warehouse foundation

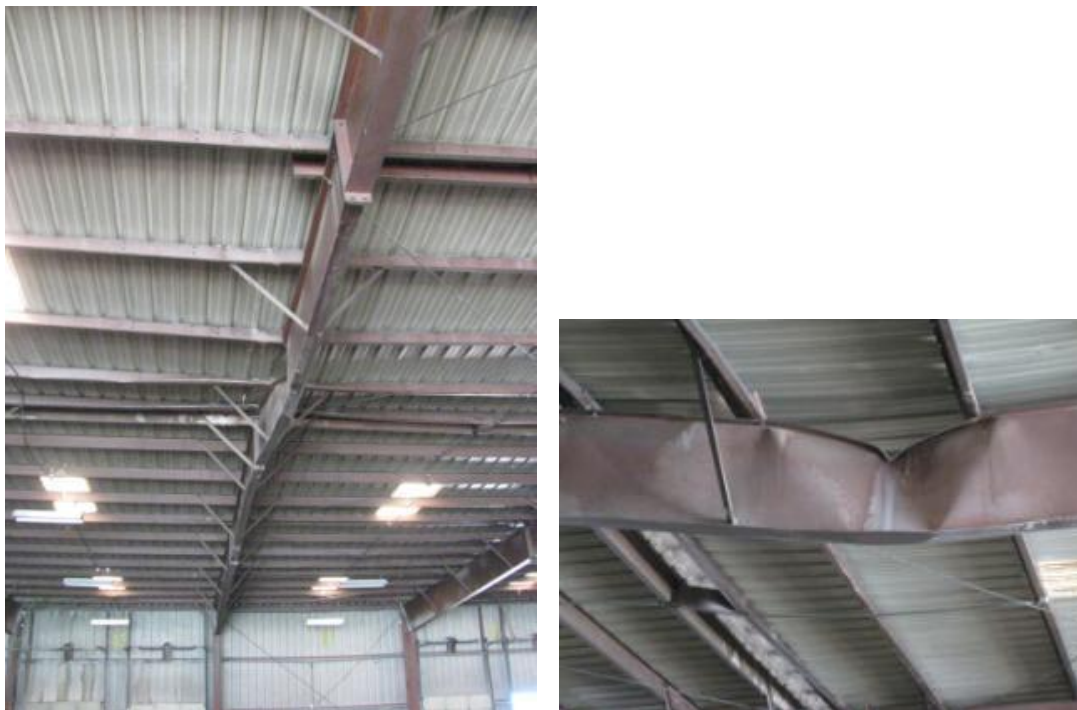
Figure 7.4: Buckling of warehouse roof beams

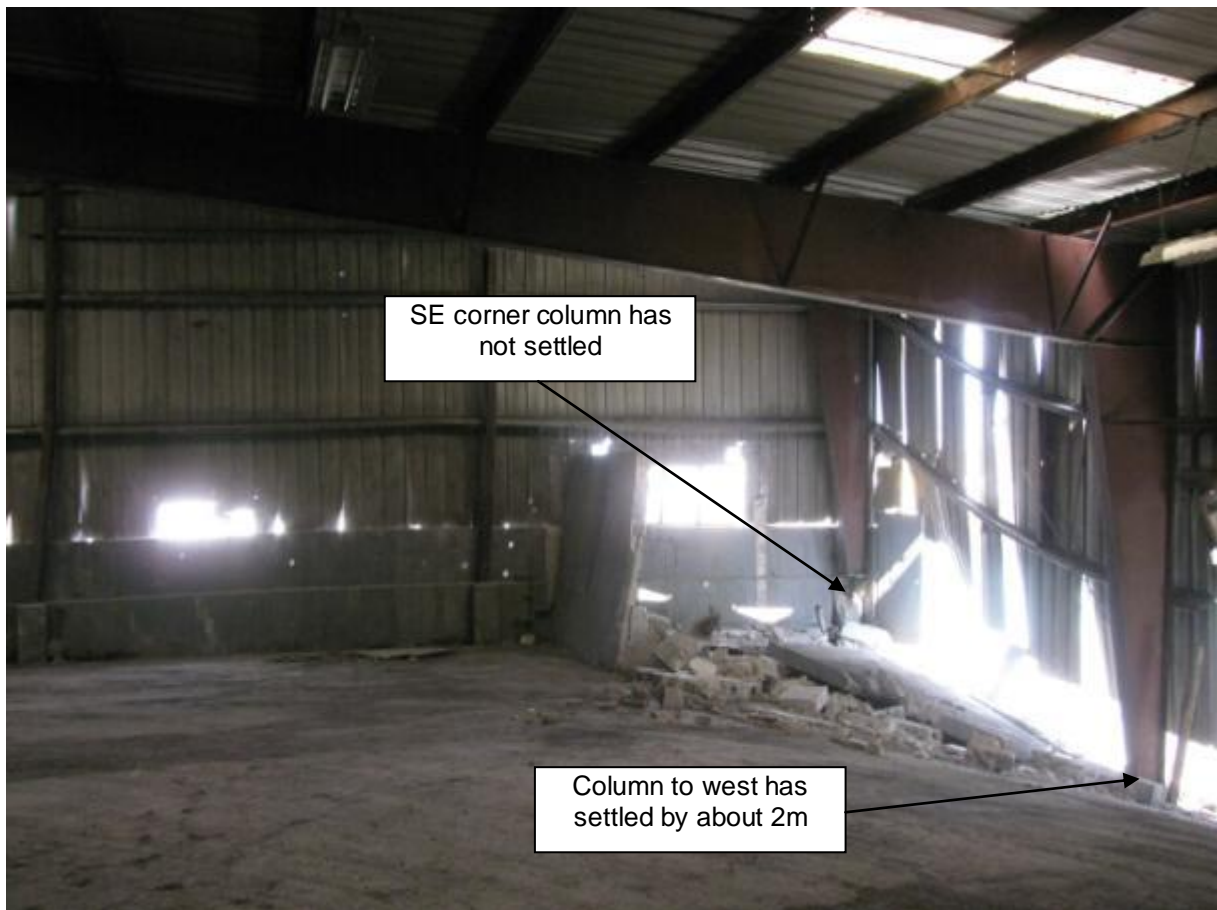
Figure 7.5: Settlement of columns in SE corner of warehouse

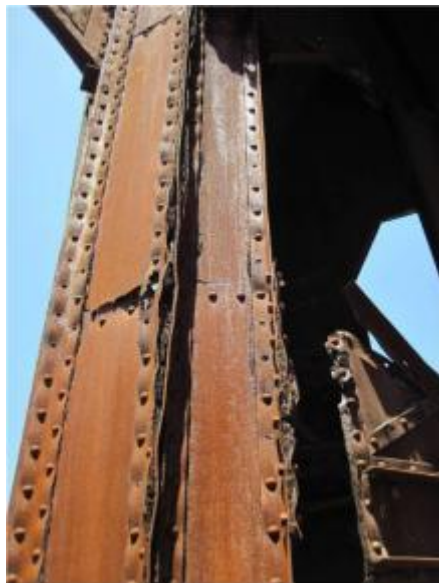
Figure 7.9: Corrosion of a column in the clock tower

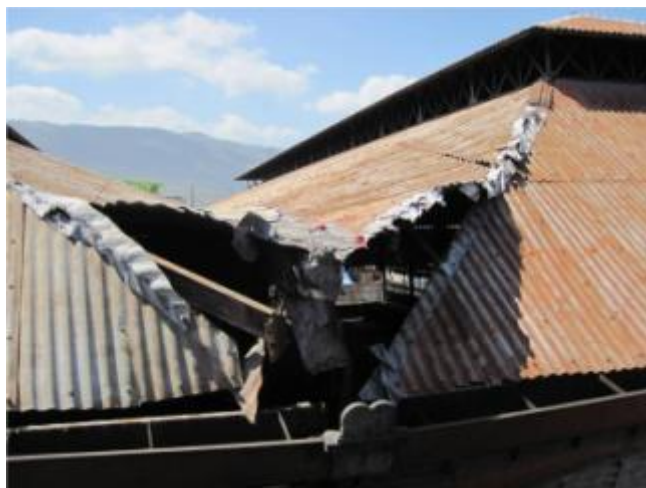
Figure 7.10: Corrosion around roof valley in south market

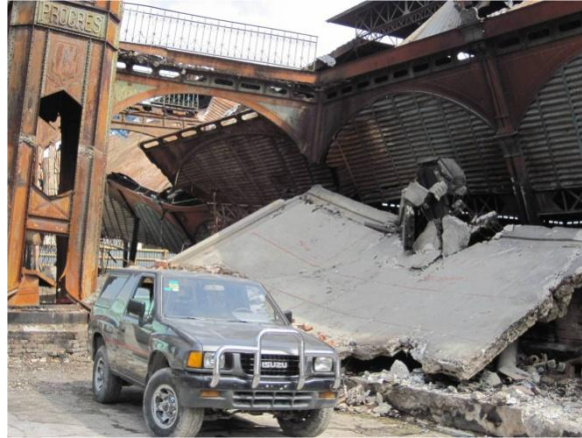
Figure 7.11: Failure of concrete canopy adjacent to north west corner of south market

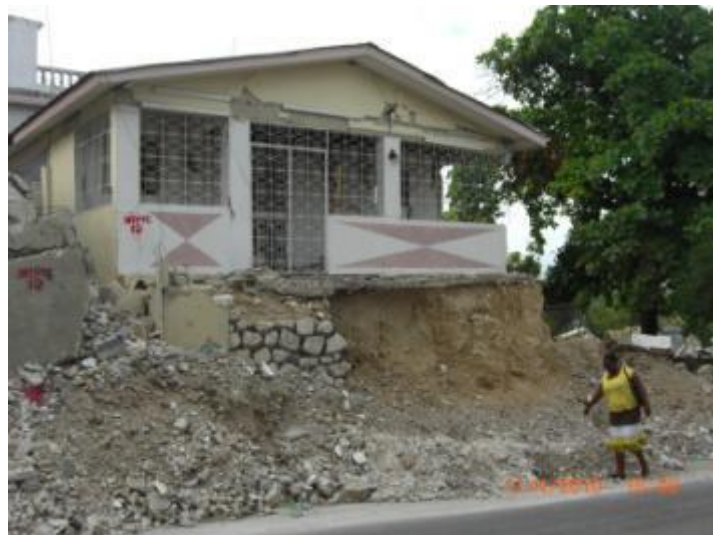
Figure 8.6: Damage to a house in location L at the top of a 10% gradient hill

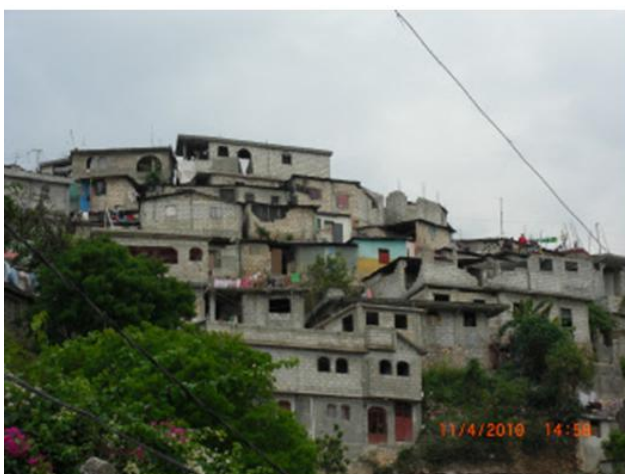
Light to negligible damage

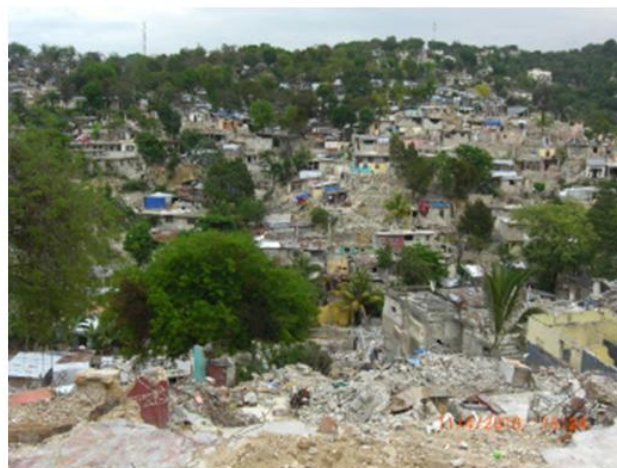
Heavy damage a few hundred metres away
