Landslides in Colombia and their impact on towns and cities

JACOBO OJEDA¹ & LAURANCE DONNELLY²

Abstract: Each year landslides in Colombia cause loss of life and widespread damage to towns and cities. Many of the major cities, such as Bogotá and Medellín, have experienced rapid, uncontrollable expansion of the population over the past few decades, due to migration from the rural areas to urban centres. Due to the relatively high cost of living space, homes are built on the steep, middle and upper valley slopes which are susceptible to mass wasting. The slopes above Medellín have resulted in at least three known catastrophic landslides. The failure of thick residual soils, overlying intensely fractured bedrock, occurs during torrential storms or following prolonged heavy rainfall. In 2003 for example, at least 13 persons were killed, 20 remain missing, and more than 300 homes were destroyed after overnight rains in western Colombian towns in the Caldas district. Landslides may also be induced by earthquakes, such as those which occurred in 1999 in the Eje Cafetero, central part of Colombia and in 1995 in Tauramena. These block roads, damage communications and utilities and often is

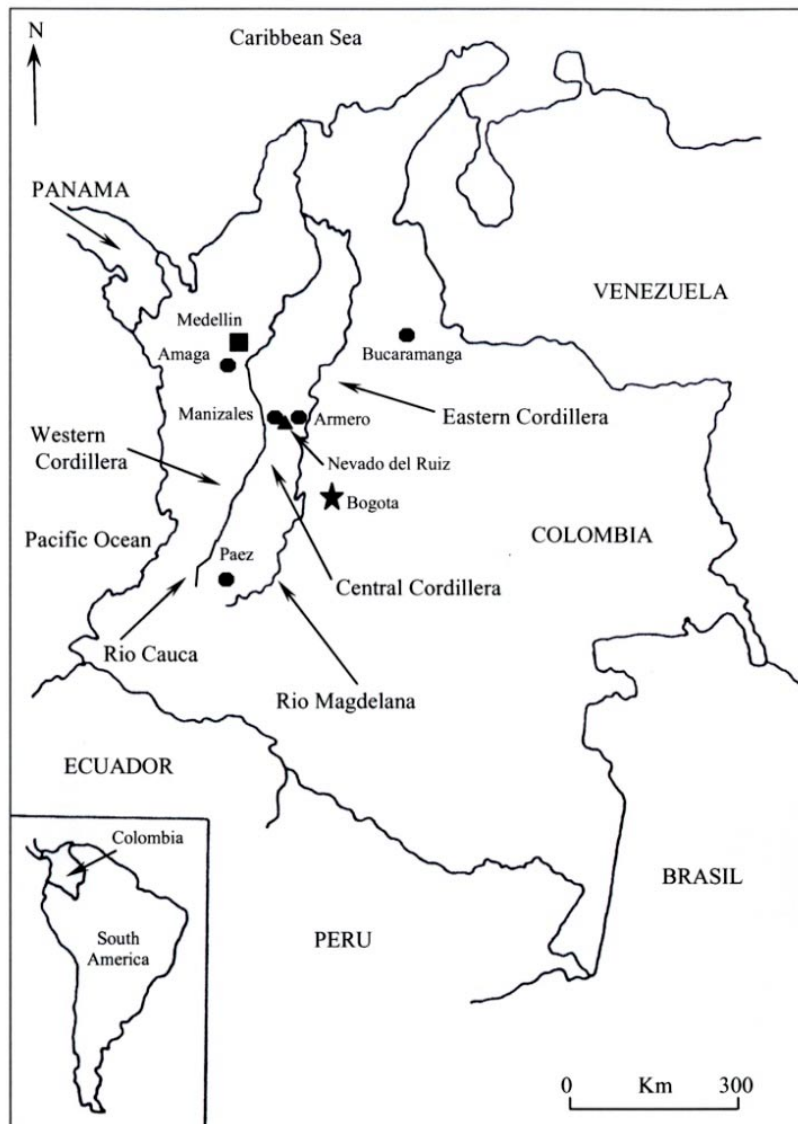
Figure 1. Map showing the Andean Cordilleras and landslide sites referred to in this paper.

Colombia is dominated by three, north-south trending, mountain belts; the western central and eastern Andean Cordilleras. The north-south trending, fault controlled Magdalena and Cauca valleys divide the three principal ranges. The basement consists of polymetamorphic schists, known as the Palaeozoic Schist Belt. Colombia is traversed by several active, major crustal fault systems, with a general south-west to north-east trend direction. These faults are related to the tectonic setting and evolution of Colombia since the entire country is situated in the Nazca-Southamerica-Caribe plate convergence zone. The relative movement of these three plates, during the Cenozoic period, resulted in the generation of the three cordilleras (Pardo & Molinar 1987). The relative movements along these faults are responsible for numerous moderate to high magnitude earthquakes, which may subsequently induce landslides on steep slopes. Furthermore, the faults increase landslide susceptibility due to the increase in rock mass discontinuities and higher weathering rates in faulted bedrock. The Central Cordillera is the oldest and highest of the three mountain ranges, it reaches up to 5750 m above sea level (mASL). Geologically, it is the most complex comprising Tertiary continental sediments, Cretaceous intrusive and extrusive volcanic sequences and Palaeozoic schists. These have been subjected to multiple phases of folding, faulting, metamorphism and intrusion by batholiths and suites of dacite porphyries (McCourt & Feniniger 1984; McCourt 1984) (Figure 1).

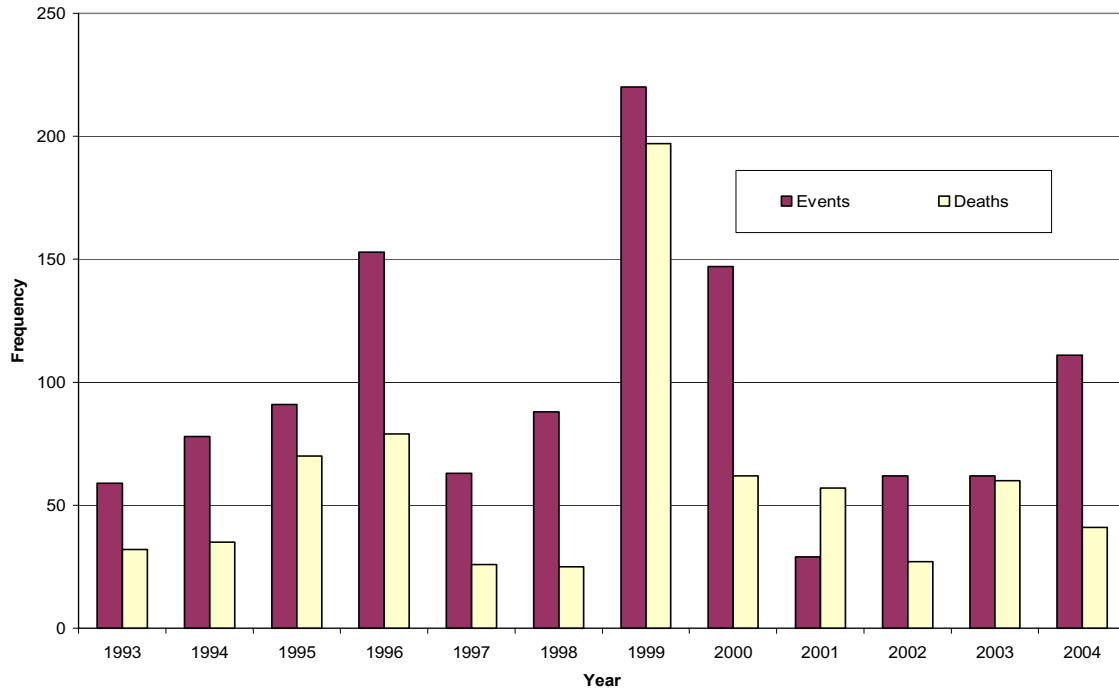
Figure 3. Number of landslides and deaths in Colombia, from 1993 to 2004 (source, Colombian Bureau for Disaster Relief, DGPAD 2005).

The actual number of deaths caused by landslides in Colombia is not known. Records of deaths related to landslides have been estimated by the Colombian Bureau for Disaster Relief (DGPAD 2005) for the period 1993 to 2004. An estimated 97 landslide events took place each year, during this time period, with 59 deaths per year (Figure 3).

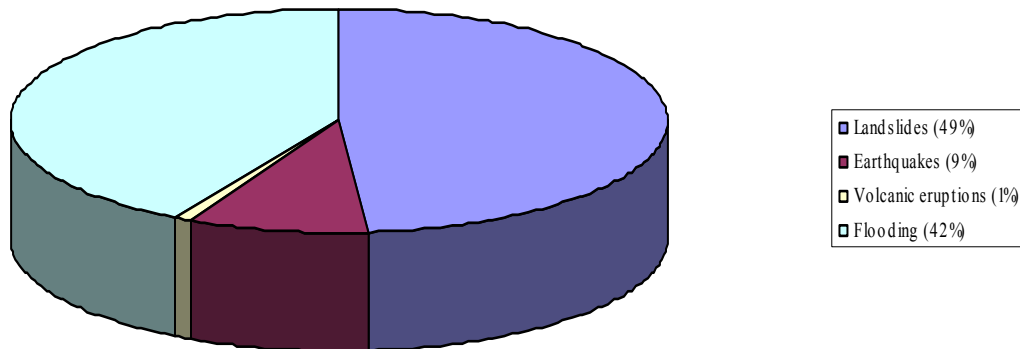
Figure 4. Distribution of Catastrophic Events in Colombia, 1920 to 1990 (source: INGEOMINAS)

Over a longer time period, from 1912 to 1997, it was found that there were 32 landslide events per year and 73 deaths (Montero & Ojeda 2005). However, the death toll of annual deaths rises to 340 per year if the 1985 Armero lahar is taken into account. Landslides account for almost half of all geological hazards in Colombia, which may be regarded as catastrophic events (Figure 4).

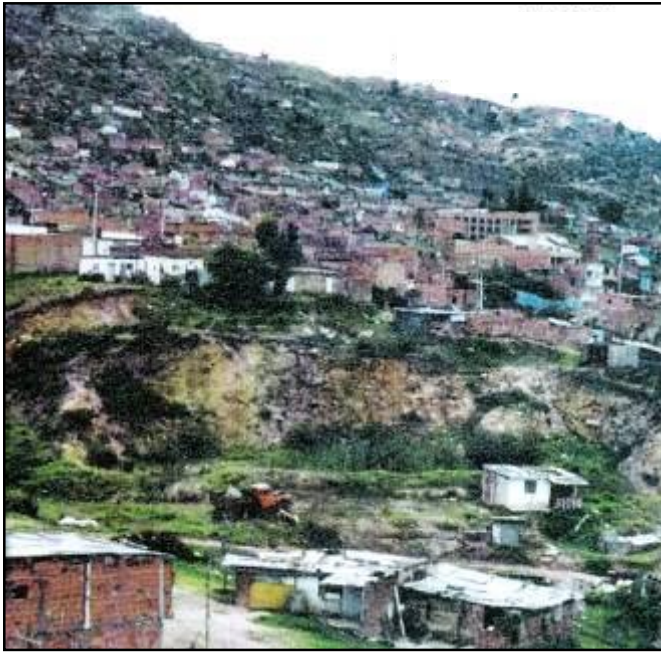
Figure 5. Crowded and poorly planned settlements on steep hill slopes around Bogotá (Gonzales 2005).

Bogotá, the capital city of Colombia, has an estimated population of approximately 7 million. Most of the inhabitants have settled on ancient lacustrine deposits at about 2600 mASL, now underling most of the city. This forms a basin which is surrounded by mountainous terrain with high relief, belonging to the Eastern 'Andean' Cordillera. The urban development of the city has progressed from the south, in a northerly direction along the flanks of the mountains. These areas of higher relief are composed of sedimentary rocks, which are highly fractured and covered by thick colluvium, alluvium, river terrace sand and gravels, fluvio-glacial and fan deposits. Natural denudation processes, mining (for construction material and brick manufacturing), have given place to potentially unstable ground conditions. These have been subsequently occupied by human settlements (Figure 5).

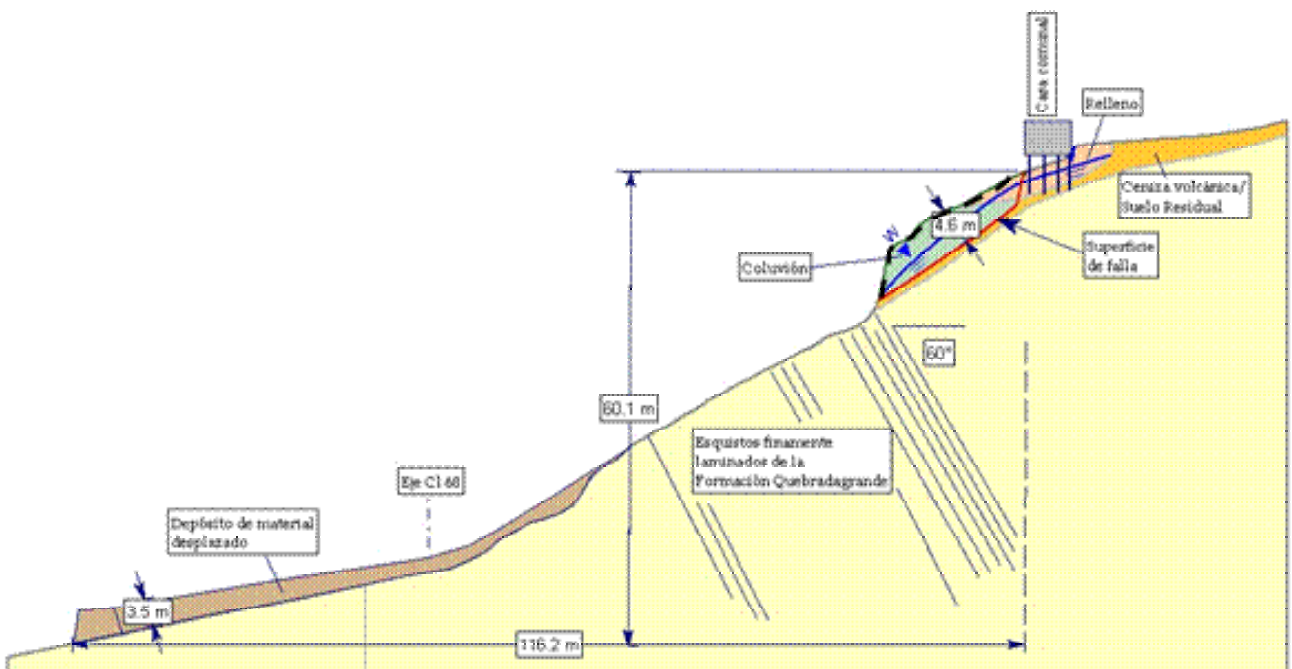
Figure 7. Cross section of slope depicting slope condition before (green) and after landslide (brown) in La Sultana landslide (Ojeda & Barreto 2005).

This city of about 700,000 inhabitants is located in the western flank of the Central Cordillera at approximately 2150 mASL. The city is dominated by steep slopes and high relief. Many of the houses, buildings, roads and infrastructure have been constructed by cutting into, or filling slopes. Weak, unconsolidated, volcanic ash covers many parts of the city and in places this reaches 50 m thick (Aguirre 1993). This covers older, but geologically ‘recent’ volcanic and volcanoclastic bedrock. Manizales experiences anomalously high rainfall. In 2003, rainfall registered a maximum 24 hours ‘peak of precipitation’ since 1970. At least 200 landslides were triggered by the rainfall. The most disastrous landslide occurred in the neighborhood of La Sultana, at mid-day, on 4 December 2003. This was a relatively small, translational slide-debris flow, about 2400 cubic metres in size, which traveled a horizontal distance of 73 meters. The landslide killed 16 people, destroyed 8 houses and affected another 46. The slipped mass included a component of the deposit from a former landslide, composed of volcanic ashes, which became displaced along the contact with the underlying schist bedrock. This event was triggered by an increment increase of pore water pressure due to rainfall infiltration and runoff, emerging on the upper parts of the slope (Ojeda & Barreto 2005) (Figure 7 and Figure 8).

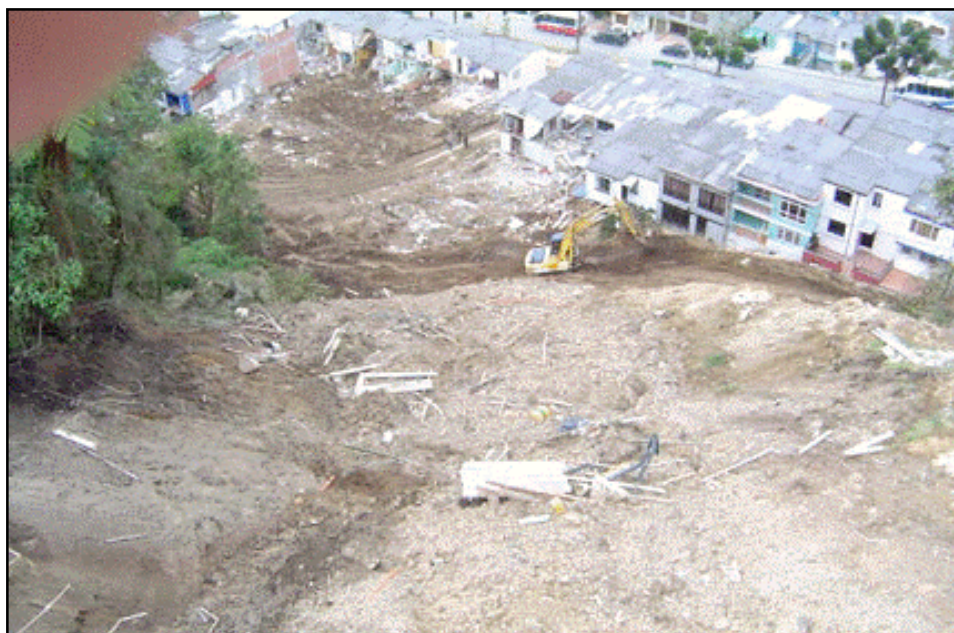
Figure 8. La Sultana (Manizales) landslide looking down slope (Photograph: R. Mendez)

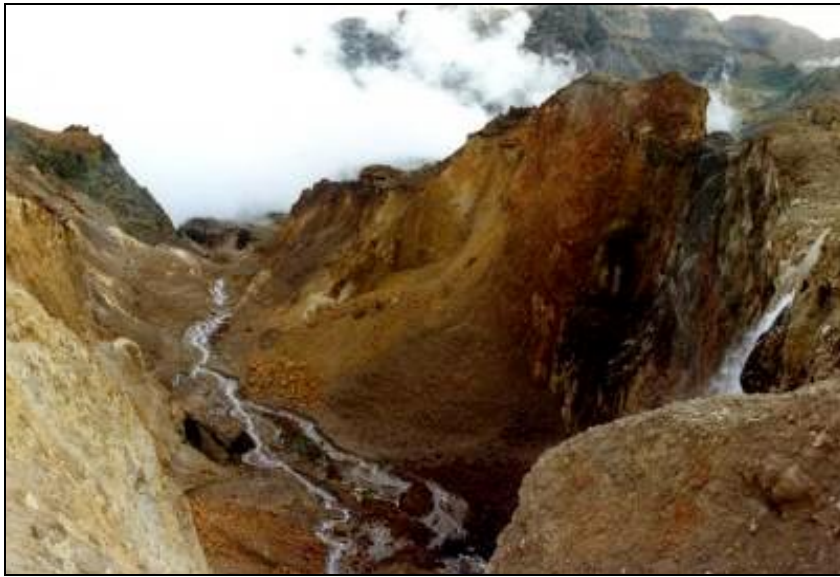
Figure 9. The Upper Lagunillas valley, close to the summit of Nevado del Ruiz. The Lagunillas valley carried the deadly lahars to Armero. The walls and floor of the valley were scoured and eroded to produce a steep sided canyon. Secondary landslides and rock falls may be observed on the flanks of the over steepened valley (Donnelly 1997c).

eruption the canyons contained large quantities of unconsolidated sediment. Landslides were common throughout the volcanic massif. In one instance a single landslide dammed an approximate 25 m deep lake, which was impounded in the lower Rio Lagunillas canyon. The eruptive history of Nevado del Ruiz is well documented for the Quaternary (Williams 1990a, 1990b) (Figure 9 and Figure 10).

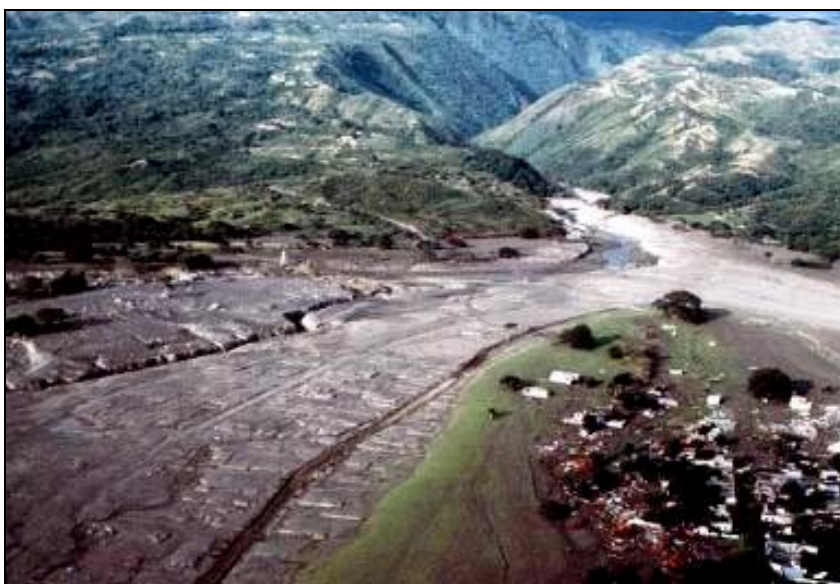
Figure 10. Armero covered by the lahar; the mouth of the Lagunillas river valley in upper part of the photograph (INGEOMINAS 2002)

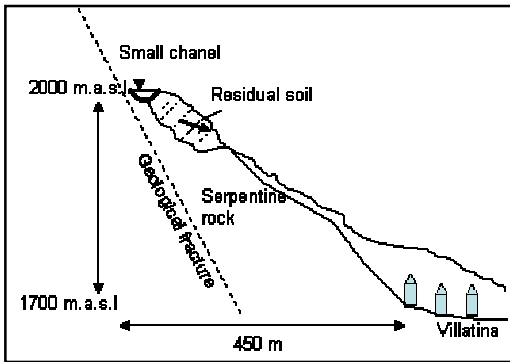
Figure 11. Schematic cross section to illustrate the Villatina landslide, Medellin (Modified after Suarez 1997).

Medellin is one of the biggest towns in Colombia, it is the country's second city, after the capital Bogotá, it has a population of about 4 million people. It is situated at the northern part of Central Cordillera at 1500 mASL. The city extends along the Aburra Valley and it is surrounded by mountains that reach at least 3000 mASL. The valley consists of deposits of volcanic ashes, alluvium and colluvium which overlie igneous basement rocks. The serpentinised bedrock is susceptible to intense, tropical weathering, resulting in a thick residual regolith comprising weathered bedrock and soil (Toror 1988). A catastrophic landslide occurred on 27 September 1987 in the neighborhood of Villatina. This was triggered by water leakage from a small, artificial channel located in the upper part of the mountain slopes. This landslide involved the movement of approximately 40,000 cubic metres of residual soil. This killed about 500 people, affected a further 1300 and destroyed 120 houses (Ojeda & Velásquez 1996; INGEOMINAS 2002; Suarez 1997) (Figure 11 and Figure 12).

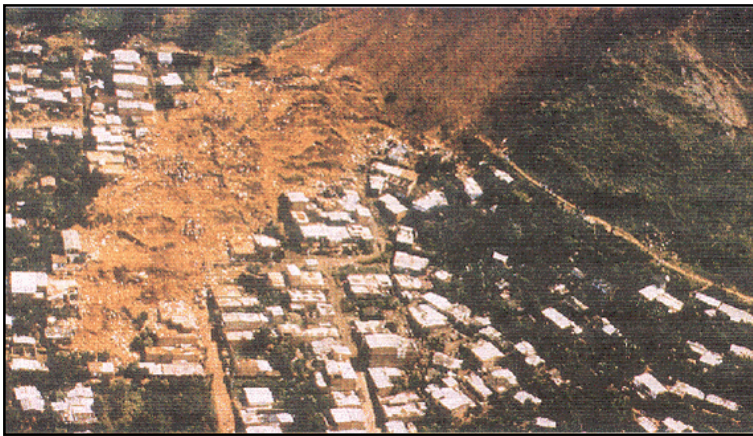
Figure 12. The Villatina landslide, Medellin, which killed 500 people in 1987.

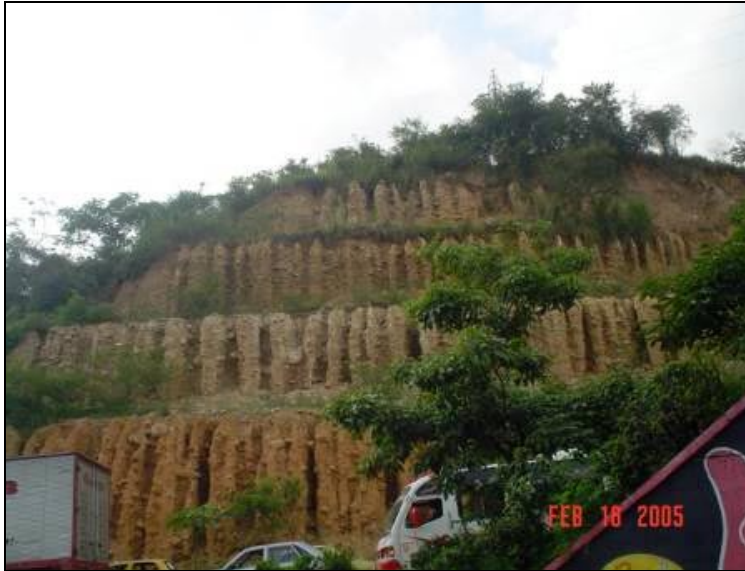
Figure 13. Gullying and channel erosion in alluvial fan deposits (Organos member), Bucaramanga (Castro 2005).

Bucaramanga is a city of about 1.5 millions inhabitants and is located in the Eastern Cordillera, in the north-east of Colombia at 1000 mASL. The geomorphology of the region is strongly influenced by two, intersecting major fault systems, and associated tectonic processes. Lateral movements along these faults have generated a tectonic basin which subsequently became filled with sedimentary deposits. In places alluvial fans, along the valley sides exceed 250 m thick. The alluvial fan deposits consist of four distinct units. The upper part is composed of yellow, redish clayey sand, gravels and silt. This overlies a sandy-clay with interbedded gravel and subrounded boulders up to 800 mm in diameter. This in turn, overlies interbedded clay and sandy silt. The fourth, basal member, crops out throughout the city on roadside cuttings and scarp slopes. This is known as the 'Organos member' and is composed of boulders and gravels within a sandy clay matrix that is easily eroded by surface run-off generating gullies and erosion channels. Prolonged heavy rains, from 9 to 12 February 2005, resulted in about 142 mm of rain falling in 24 hours. Widespread flooding resulted and this induced at least 1000 landslides. Approximately 5082 houses were destroyed and 39 people killed by mud and debris flows (Castro 2005) (Figure 13 and Figure 14).

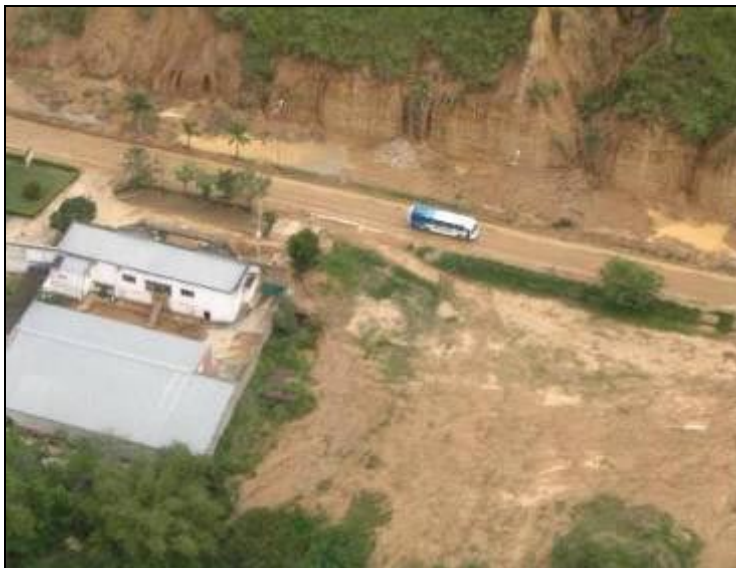
Figure 14. Debris flow in Bucaramanga (Castro 2005).

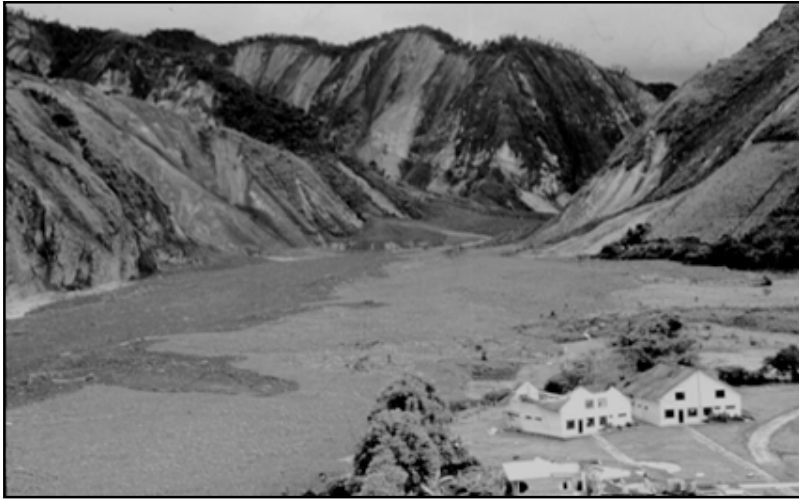
Figure 15. A view of landslides and debris flow along Páez River (INGEOMINAS 1994)

On 6 June 1994, the Páez river valley region, in southwest Colombia, experienced an earthquake of magnitude 6.4 Ml. This triggered multiple landslides that generated huge debris flows along the Páez, Mora and San Vicente rivers. The debris flows reached 60 m high in some places, and velocities between 15 to 20 metres per seconds (INGEOMINAS 1994). The landslides were mainly translational slides with thickness between 1.5 and 7.0 m.

Estimated volume of displaced debris was in the order of 318 million cubic meters (Calderón, Avila & Ojeda 1997). This event devastated around 5500 cubic kilometres of land, buried two villages, destroyed almost 1700 houses, 6 bridges and about 100 km of roads. Approximately 900 people were estimated to have been killed (INGEOMINAS 1994; Ojeda *et al.*, 2004) (Figure 15).
