TYPHOON HAIYAN (YOLANDA) SHELTER RESPONSE OUTCOME ASSESSMENT

FINAL REPORT

PHILIPPINES

MAY 2016

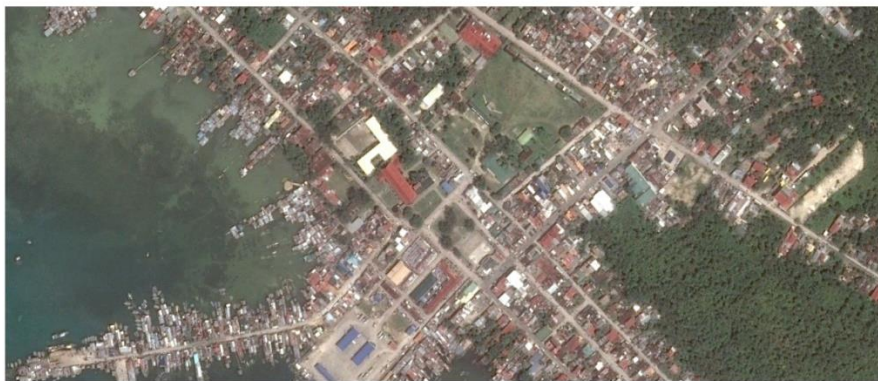
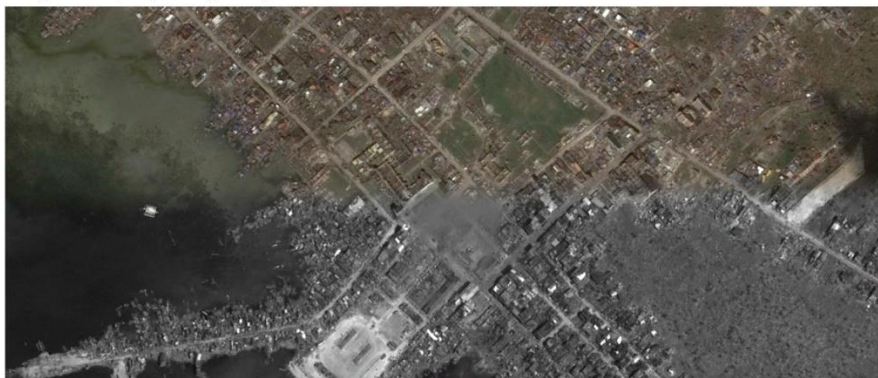
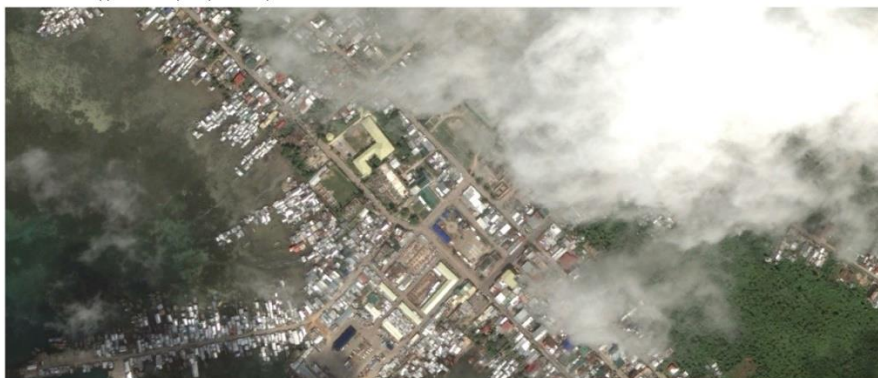
Satellite imagery 1: Guiuan imagery comparison before, just after and one year after Yolanda

The imagery comparison from Guiuan below shows how households that prior to Yolanda (27 August 2013) did not use CGI sheets, had by 7 November 2014 used the sheets for roofing. The imagery also shows how households rebuilt their homes along the shoreline, despite the apparent lack of safety when facing future typhoons.

Pre-Typhoon Haiyan (Yolanda), 27 August 2013

Aftermath of Typhoon Haiyan (Yolanda), 15 November 2013

One year after Typhoon Haiyan (Yolanda), 7 November 2014

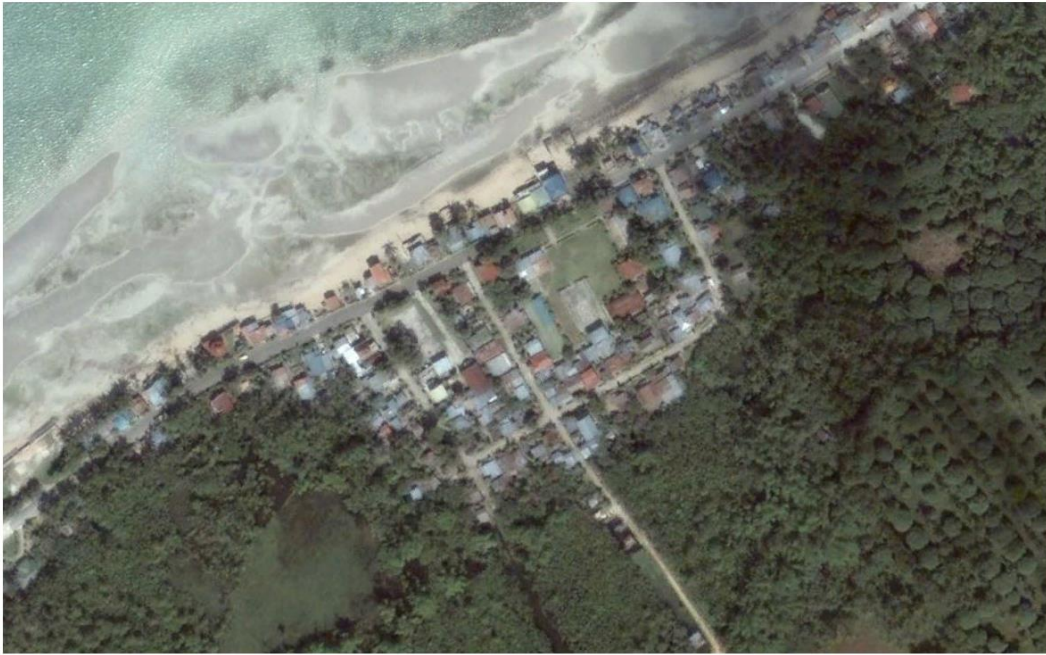
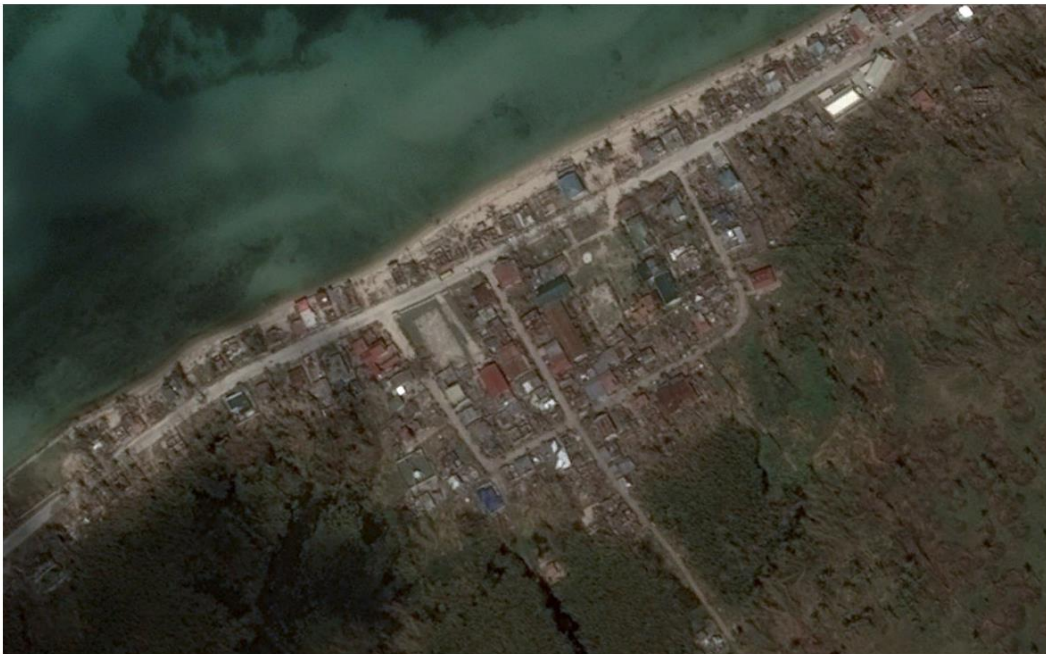
Satellite imagery 2: Paypay before and just after Yolanda

Post-recovery satellite imagery of Paypay barangay in Northern Cebu is not freely available but analysis of images showing the location before and just after Yolanda shows the devastation not only of dwellings but of the surrounding tree-cover.

Pre-Typhoon, 20 November 2005

Aftermath of Typhoon Haiyan (Yolanda), 14 November 2013

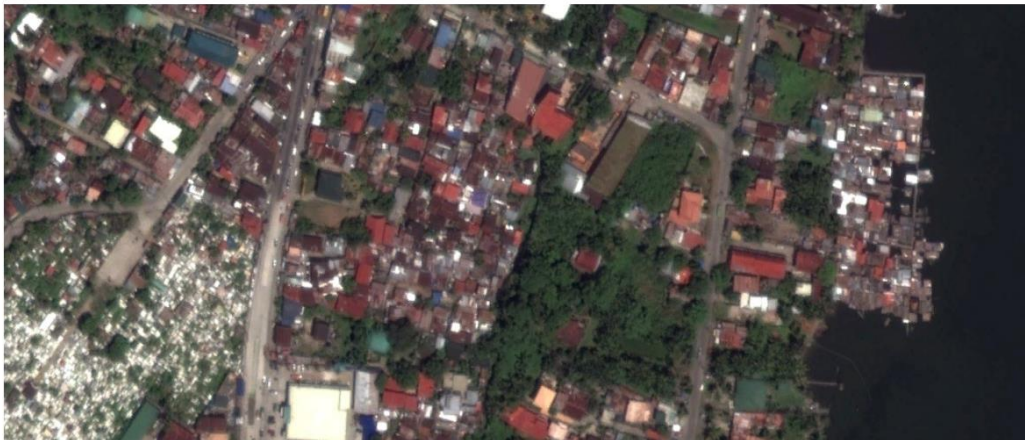
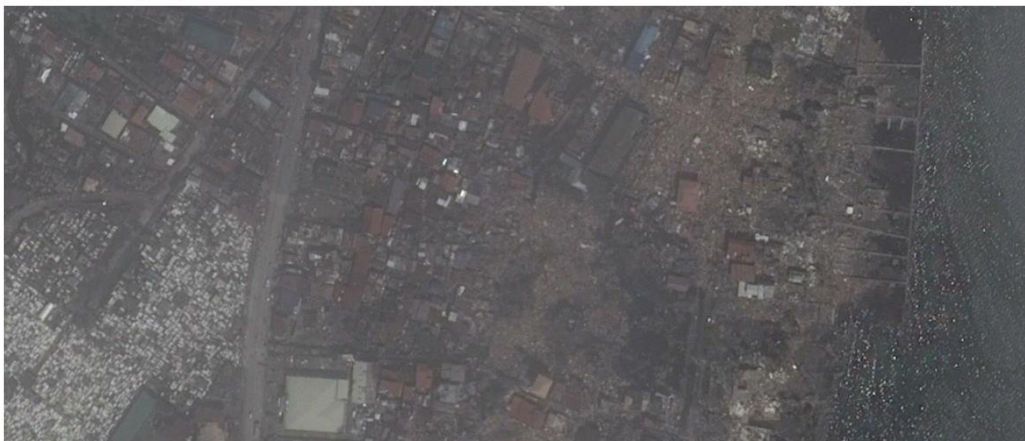
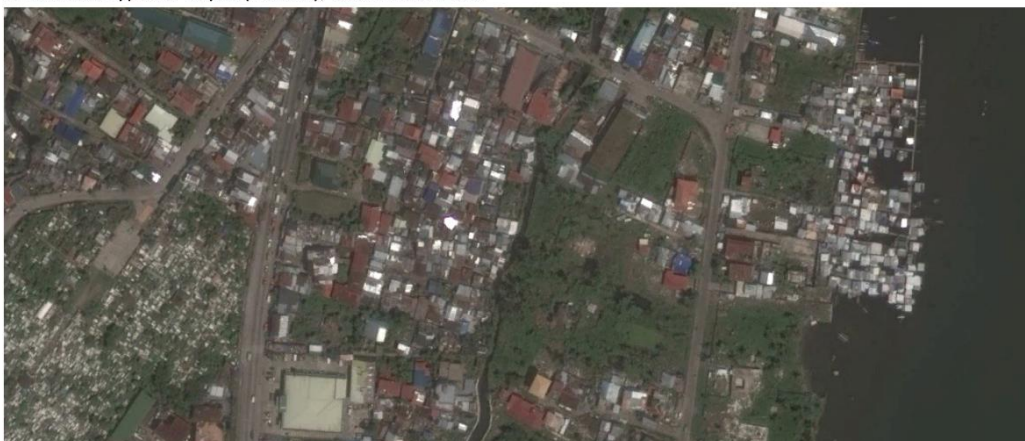
Satellite imagery 3: Tacloban Barangay 56A before, just after and 9 months after Yolanda

The increase in CGI sheet use is also evident when studying pre and post typhoon imagery of Tacloban Barangay 56A in Leyte, particularly along the shoreline where people had rebuilt their homes 9 months after Yolanda, despite the evident risk faced here in the face of future typhoons. Reduction in tree cover can also be seen.

Pre-Typhoon Haiyan (Yolanda), 18 May 2013

Aftermath of Typhoon Haiyan (Yolanda), 13 November 2013

9 months after Typhoon Haiyan (Yolanda), 30 August 2014

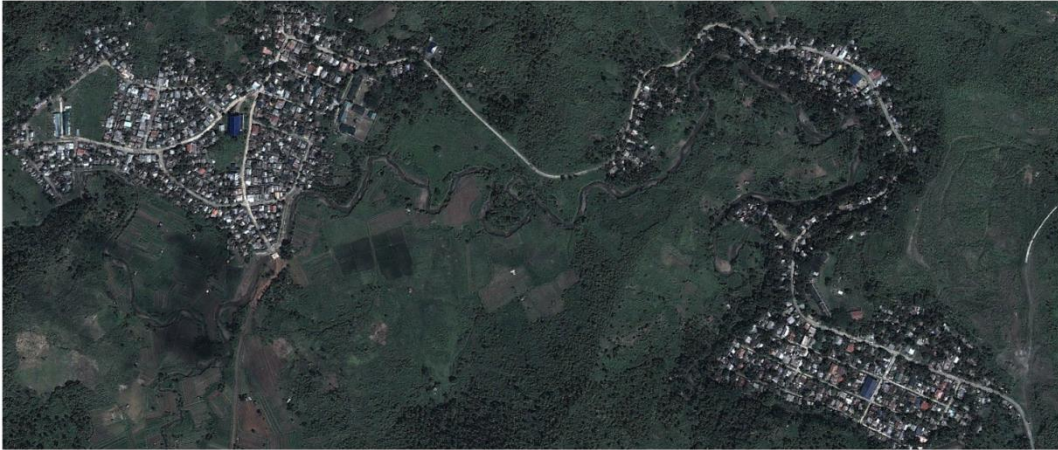
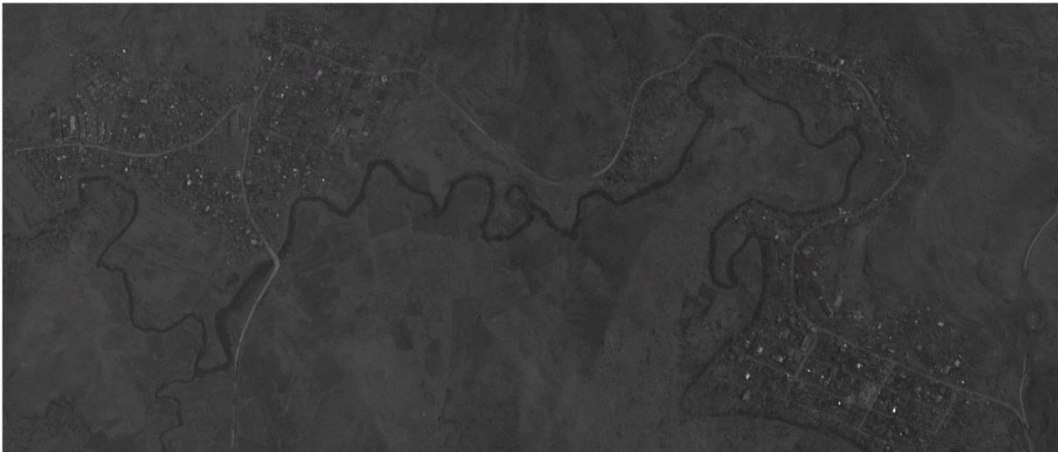
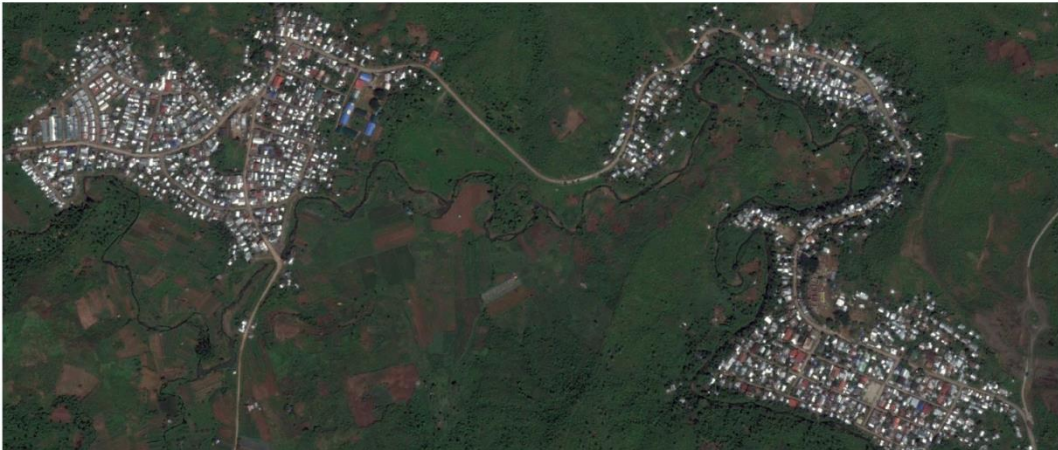
Satellite imagery 4: Palanog 103 before, just after and one year after Yolanda

The reduction in tree cover amongst houses that was complained about in Palanog 103 (Leyte) focus group discussions is apparent when viewing satellite imagery from the location. Construction of new homes for relocated households is also visible.

Pre-Typhoon Haiyan (Yolanda), 23 February 2012

Aftermath of Typhoon Haiyan (Yolanda), 11 November 2013

One year after Typhoon Haiyan (Yolanda), 12 November 2014

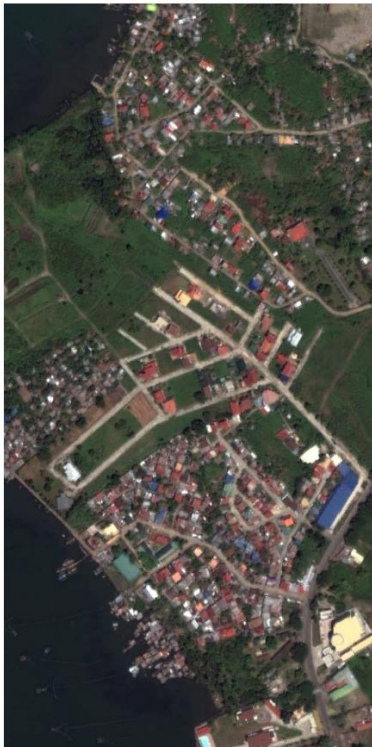
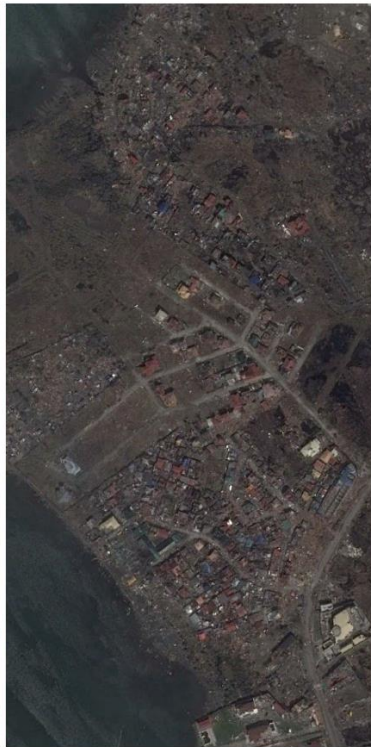
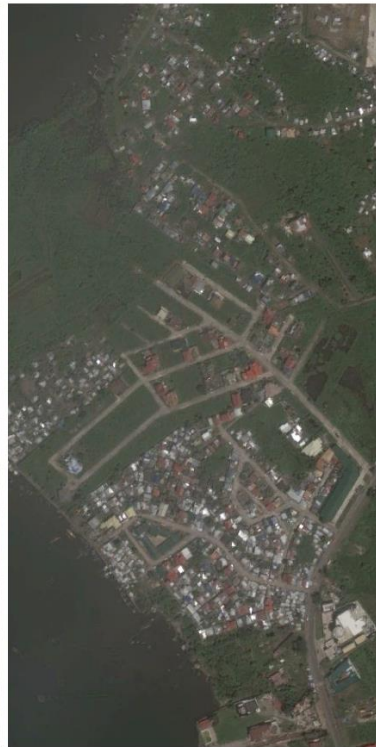
Satellite imagery 5: Tacloban Barangay 88 before, just after and 9 months after Yolanda

Barangay 88 in Tacloban in Leyte, which covers the peninsula where Tacloban airport is located, was fully submerged by storm surges during Yolanda. The devastation is evident from satellite imagery captured just after the typhoon had passed. Here the reduction in tree cover, raised in FGDs in the barangay, is evident. It is also clear that many households have rebuilt their homes at the pre-typhoon location, including along the shoreline where they are at risk of future typhoons.

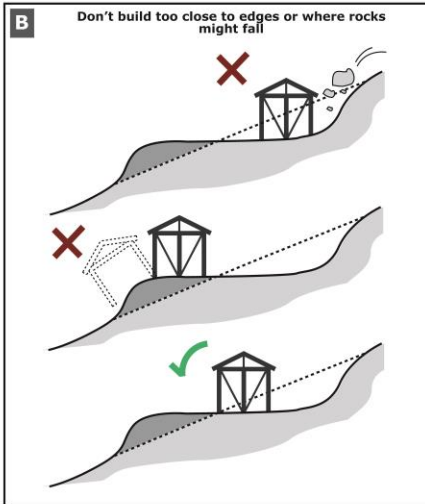
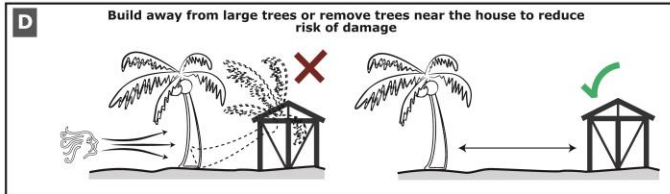
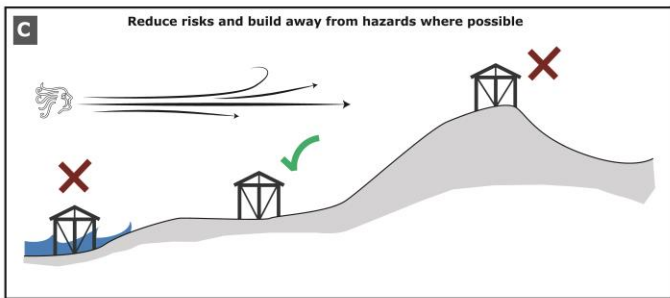
Site you house safely

Identify the hazards in your location and build as well as you can to resist them.
