THE HAITI EARTHQUAKE OF 12 JANUARY 2010

A FIELD REPORT BY EEFIT

Edmund Booth, Edmund Booth Consulting Engineer.

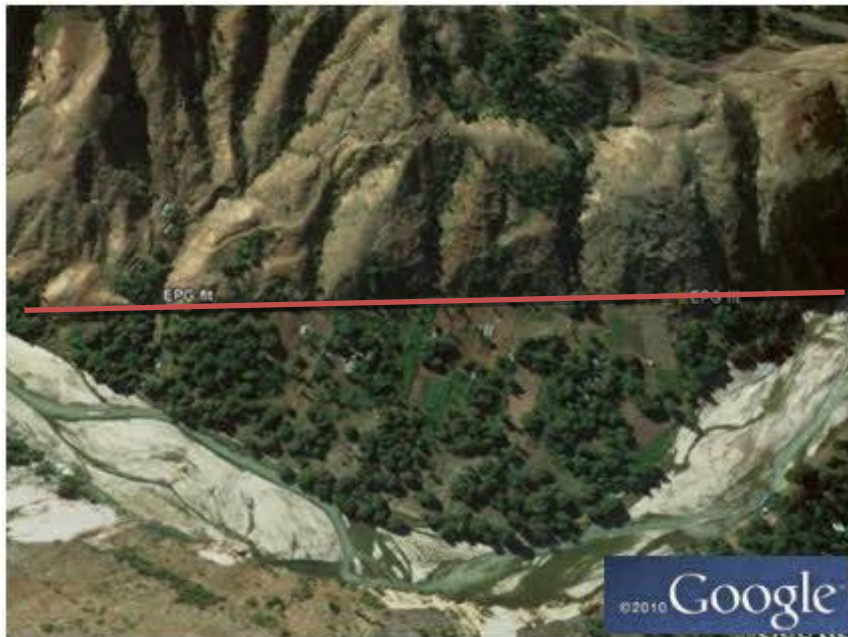
Figure 3.9: View south of prominent fault scarp crossing fluvial terrace on Momance River

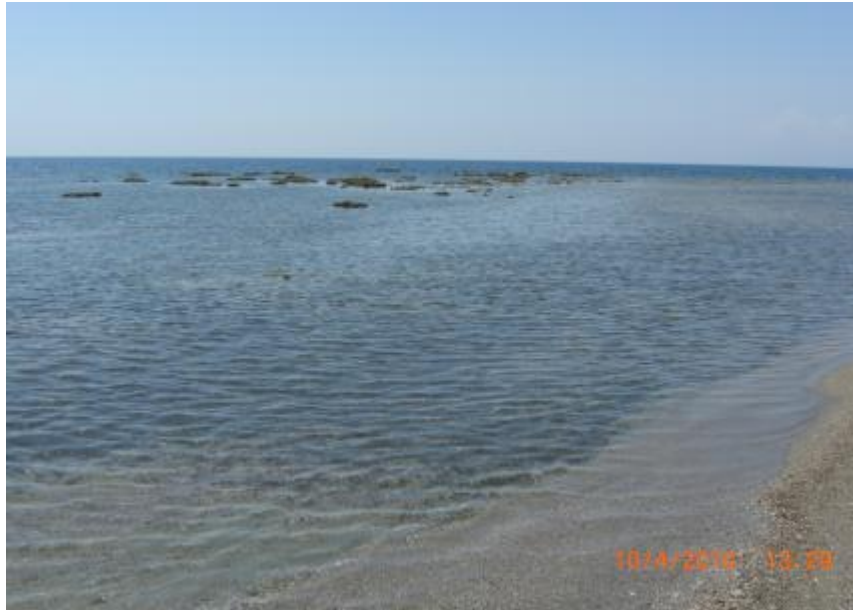
At the site near L'acul, coastal uplift was identified based on aerial images as shown in Figure 3.11. The local residents confirmed that the corals at this site were not exposed prior to the 12 January earthquake. However in Figures 3.12 and 3.13 the exposed corals can be clearly seen. The close up view of the coral in Figure 3.13 indicates that the coral has died as it was exposed to direct sunlight and dried following the coastal uplift caused by the earthquake.

Figure 3.12: Exposed coral near L'acul

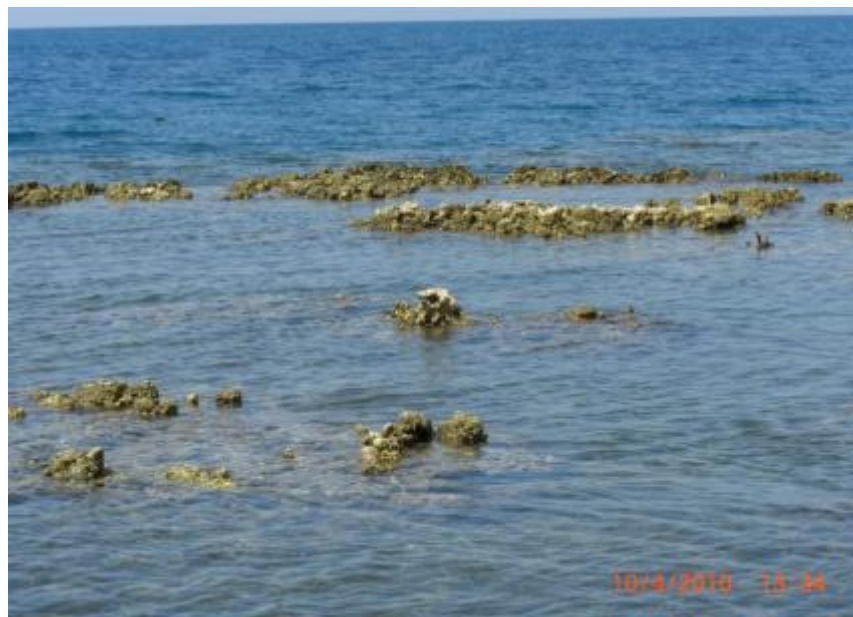
Figure 3.13: A close-up view of the coral that died due to coastal uplift

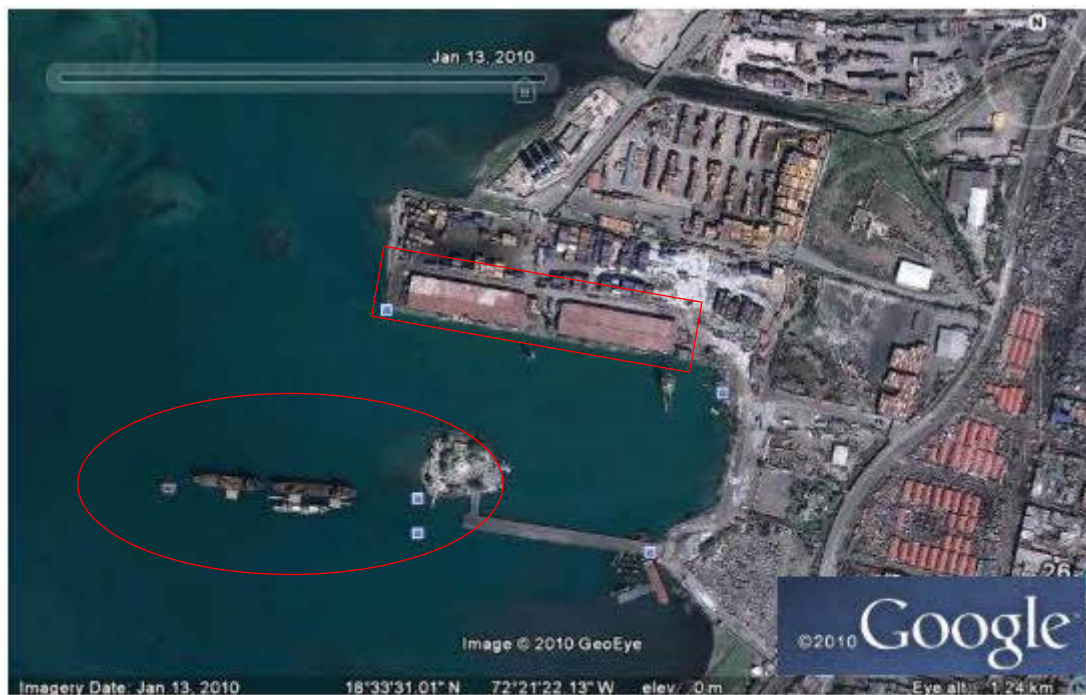
The extensive soil liquefaction that occurred at the port and the associated damage to port structures such as piers and wharves was investigated by the EEFIT team prior to the site visit using remote imagery, in addition to the ground truthing *in situ*. In Figures 4.1 and 4.2 the pre- and post-earthquake satellite images of the Haiti port are presented. Comparing these two figures it can be seen that the south pier has lost several sections and the north wharf has completely collapsed leaving the gantry crane in the water. These two main areas of damage are ringed in red in Figure 4.2.

Figure 4.2: Post-earthquake satellite image of the port facility (13th January 2010)

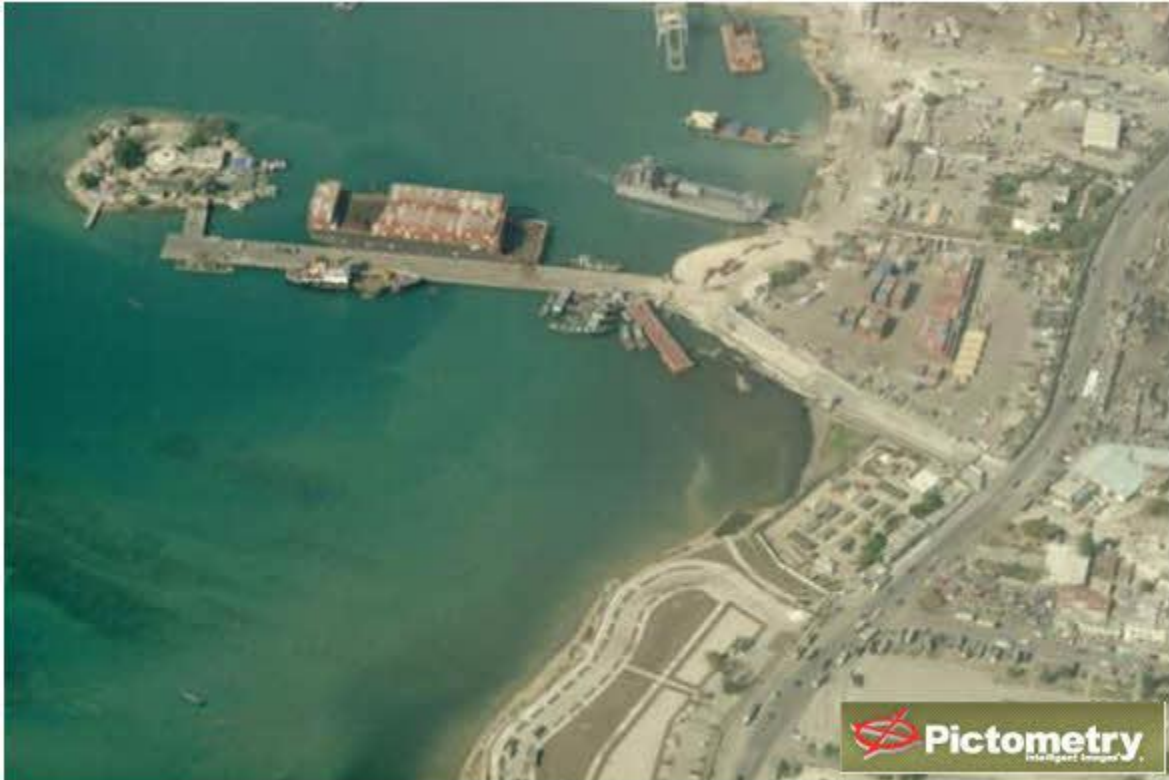
In Figure 4.3 the Pictometry image of the overview of the south pier and the island is presented. Comparing this with Figure 4.2 it can be seen Pictometry images have much higher resolution. The collapsed section of the pier is also seen on the left hand edge of this Figure. The Pictometry images were taken some time after the earthquake and therefore show the floating pontoons brought in by the US Navy, which are helping unload the containers onto the intact section of the south pier.

Figure 4.3: A Pictometry image of the overview of the south pier and the island (February 2010)

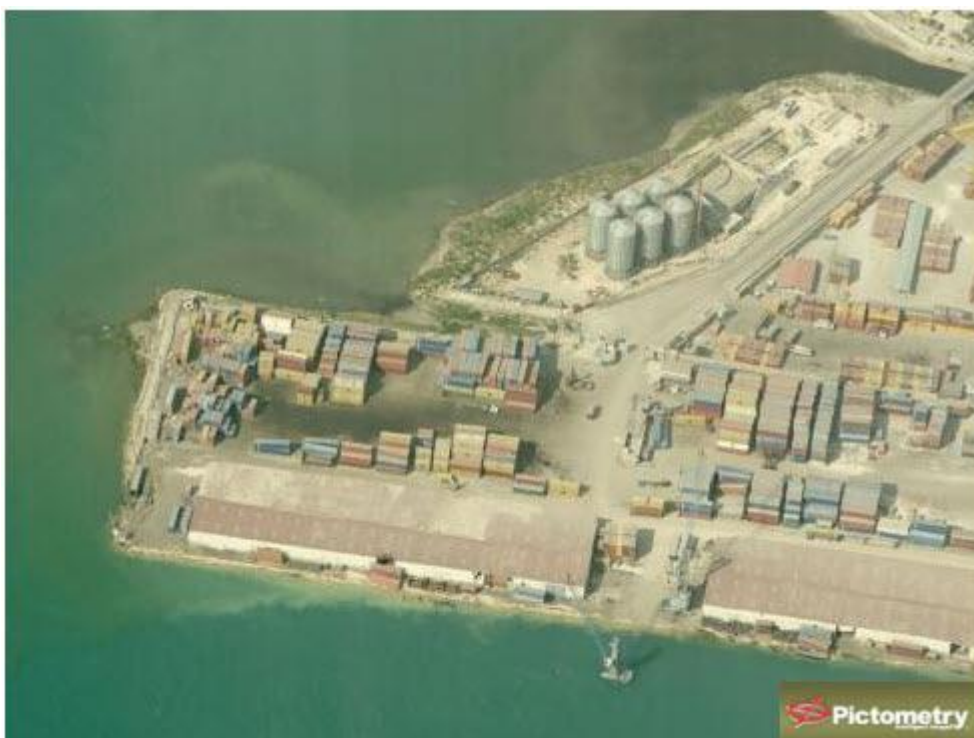
In Figure 4.4 a Pictometry image of the north wharf is presented. The collapsed north wharf is clearly seen in this Figure. Also the damage to the gantry crane is clearly seen. These correspond to the red rectangular area marked in Figure 4.2 in which the satellite image showed the same damage. Comparing Figs. 4.2 and 4.4 it can be seen that the Pictometry images offer much higher resolution and therefore increase our ability to identify damage based on remote imagery. In fact in Figure 4.4 some of the lateral spreading that occurred at this site can also be seen with extensive cracking of the ground. Similarly the island that houses the harbour master's office can also be seen at the top of this Figure. However, it is quite difficult to see the settlements suffered by the island or damage to the bridge connecting the island to the south pier or to the buildings. In Figure 4.5 a Pictometry image of the mobile crane and container storage area is shown. Large silos for bulk material storage can also be seen in this image. Although there was liquefaction induced lateral spreading that occurred close to the coastline (far left of Figure 4.5) there was no damage to the silo structures or their foundations.

Figure 4.5: A Pictometry image of the mobile crane, container storage area behind north wharf and the silo structures (February 2010)

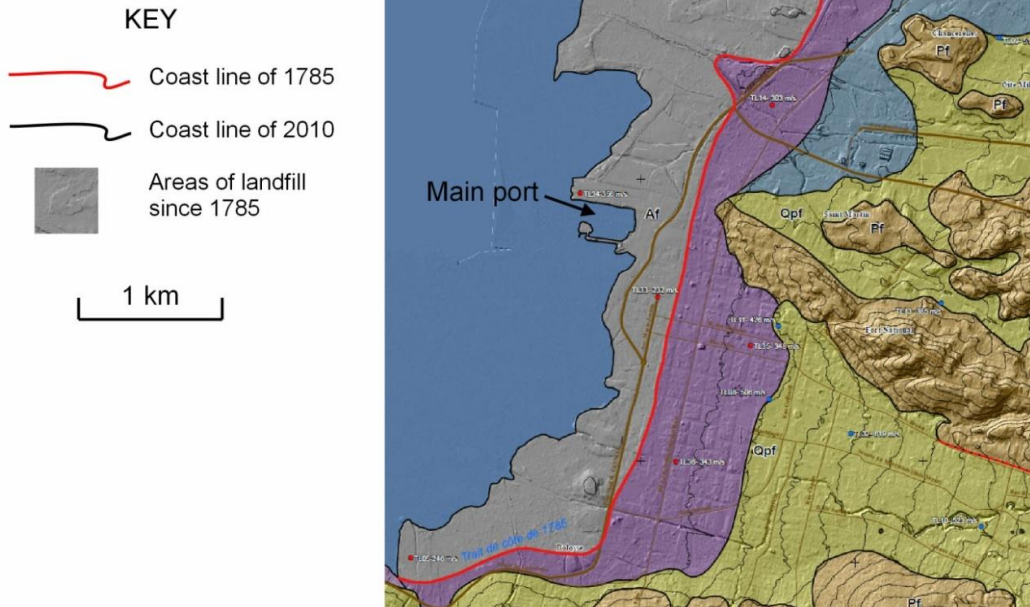
There was extensive soil liquefaction in the areas close to the north wharf identified in aerial imagery presented earlier. According to Figure 4.9, based on Bachuber *et al*, (2010), the modern port facility, and an extensive area to the north and south, was constructed on fill material, which is very susceptible to liquefaction if poorly compacted fill. The extensive liquefaction in the port area of Port-au-Prince repeats a phenomenon seen in many previous earthquakes.

Figure 4.9: Reclaimed areas around the main port facility (adapted detail from Bachuber *et al*, 2010)

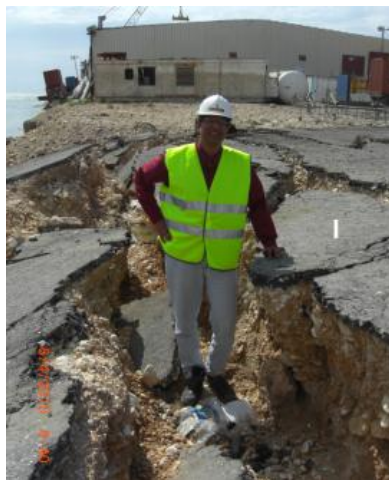
Due to the soil liquefaction there was evidence of severe lateral spreading close to the north wharf. Some of this lateral spreading was identified on the Pictometry image of Figure 4.4. Figure 4.10 shows cracks, extending to a depth of about 1m, which were induced in the tarmac next to the north wharf. The sloping angle of the ground is quite small (< 1 degree) but nonetheless there was extensive lateral spreading towards the free face. This type of lateral spreading of gentle slopes was also seen in many previous earthquakes. Figure 4.10 shows that the crustal surface layer of denser, coarser material did not liquefy but suffered lateral spreading, apparently due to liquefaction of a deeper sandy/silty deposit.

Figure 4.10: Cracks induced by lateral spreading close to north wharf extending to a depth of about 1m

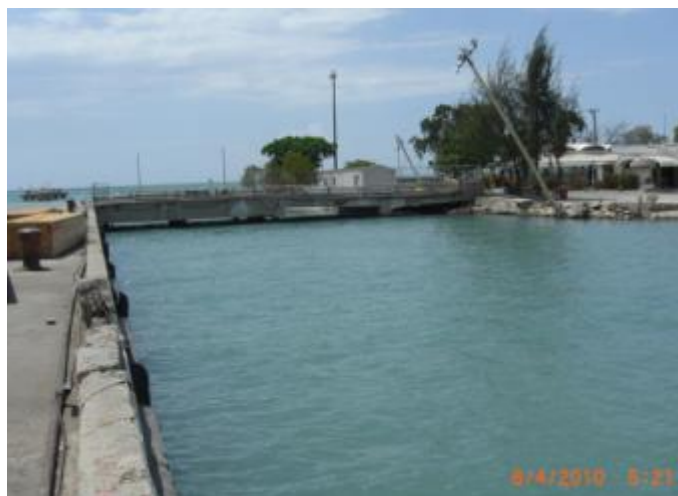
The south pier connects via a bridge to an island that houses the harbour master's building that controls the traffic movement in and out the port. The island has suffered severe liquefaction and consequently settled extensively following the earthquake. An overview of the bridge is shown in Figure 4.12. In this Figure the severe rotation suffered by an electricity pole can also be seen.

Figure 4.12: An overview of the connecting bridge linking the south pier and the island

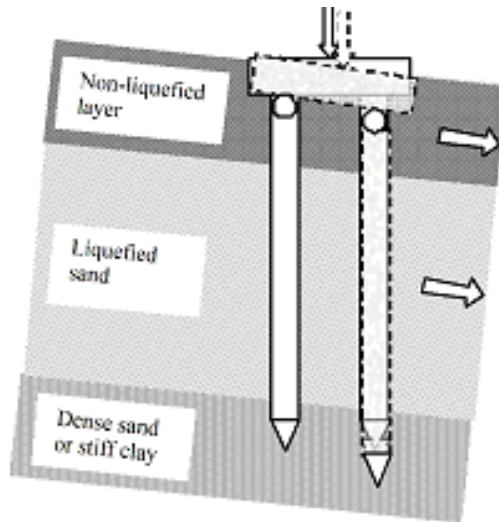
The piles supporting the wharf were passing through the liquefied and laterally spreading soil below that is moving in a westerly, seawards direction, away from the west end of the settling island and transversely to the bridge. This has led to a classical failure mechanism with plastic hinges forming at the pile heads. In Figure 4.17, the concrete at the pile heads cracked revealing the reinforcement and indicating loss of moment fixity and clear formation of a plastic hinges. This type of failure mechanism was observed earlier in dynamic centrifuge tests and was proposed as one of the possible failure mechanisms for piles in laterally spreading liquefied soils as shown in Figure 4.17 (Madabhushi *et al*, 2009).

Figure 4.17: Failure mechanism of a pile group proposed by Madabhushi *et al* (2009)

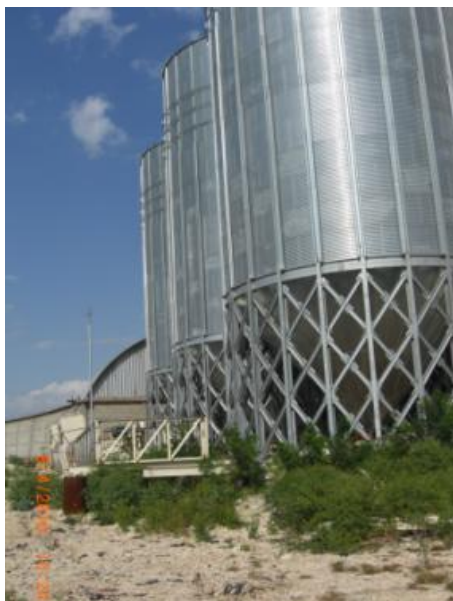
Liquefaction induced lateral spreading was observed at other locations in the port area. There was extensive lateral spreading observed behind the silo structures adjacent to the container storage facility within the port area. These silos are identified in the image shown in Figure 4.18. In this Figure the lateral spreading is clearly identified along the boundary wall. A view of the silo structures from ground is presented in Figure 4.19. The silos themselves were undamaged by the earthquake, despite the lateral spreading. However, the building adjacent to the silos had a collapsed roof and the supporting wall closest to the shoreline, seemed to have moved with laterally spreading soil causing the roof to collapse.

Figure 4.19: Silo structures that are undamaged with building with collapsed roof in the background

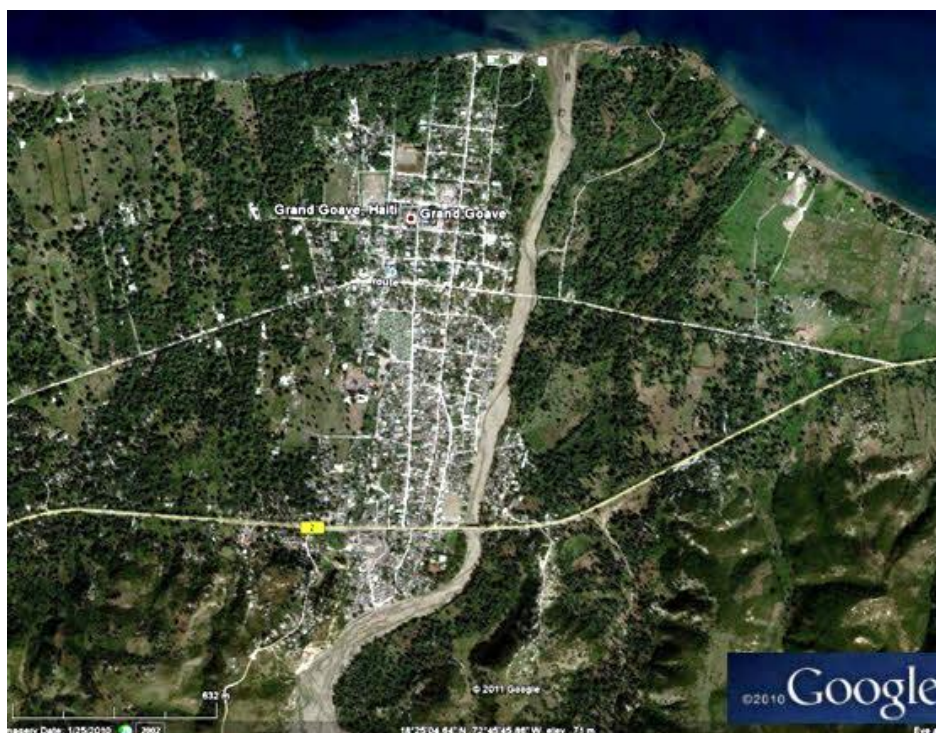
Liquefaction was also observed at several locations other than the port facility in Port-au-Prince. The EEFIT team visited one such location near Grand Goave. The GEER team (Rathje *et al* 2010) reported other locations where liquefaction was also observed. The location of Grand Goave is shown in the satellite image in Figure 4.20. It can be seen in this Figure that a river flows bounds the eastern edge of the township and joins the sea, suggesting that the area may be underlain by recent alluvial deposits, including layers of loose, non-cohesive materials prone to liquefaction. Liquefaction induced lateral spreading was seen quite close the shoreline.

Figure 4.20: Google Earth image of Grand Goave

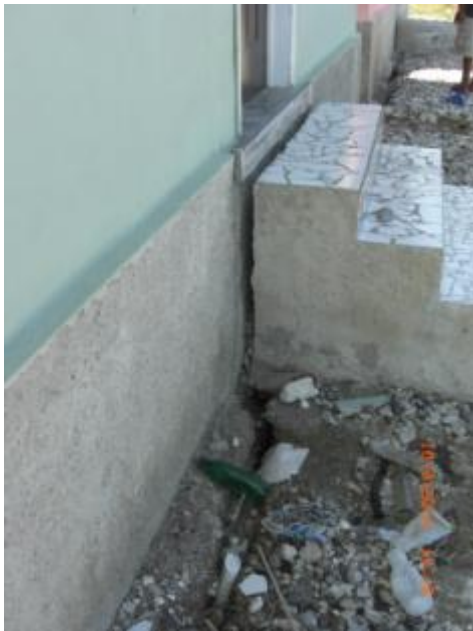
At this site the surface layers appeared to be clayey silt. Long tension cracks were visible viewed from the ground close to the buildings as seen in Figure 4.22. It appeared that this surface layer has spread laterally over a liquefied sandy layer below. As the surface layer is clayey silt with low permeability, it is likely that it was able to hold the excess pore pressures generated in the sandy layers below for an extended period, giving rise to a greater lateral spread. Buildings supported on this soil also move laterally and suffered damage as explained earlier. In Figure 4.23 a close-up view of the steps that got separated from the buildings is presented to confirm the lateral spreading of the ground.

Figure 4.23: Close-up view of the steps that separated from the buildings

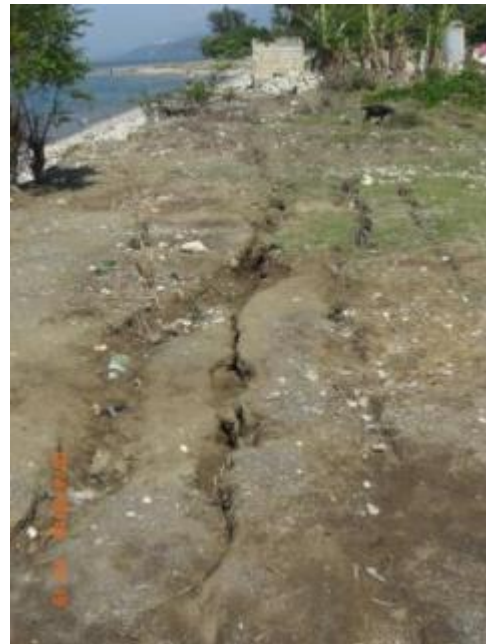
Figure 4.24: Lateral spreading continuing for some distance from the building site

The laterally spreading has continued for a long distance past the building site described above. In Figure 4.24 a view in the other direction is presented to confirm the extent of lateral spreading. This has led to several buildings with poor construction quality to completely collapse. In Figure 4.25 a view of a completely collapsed building is presented.

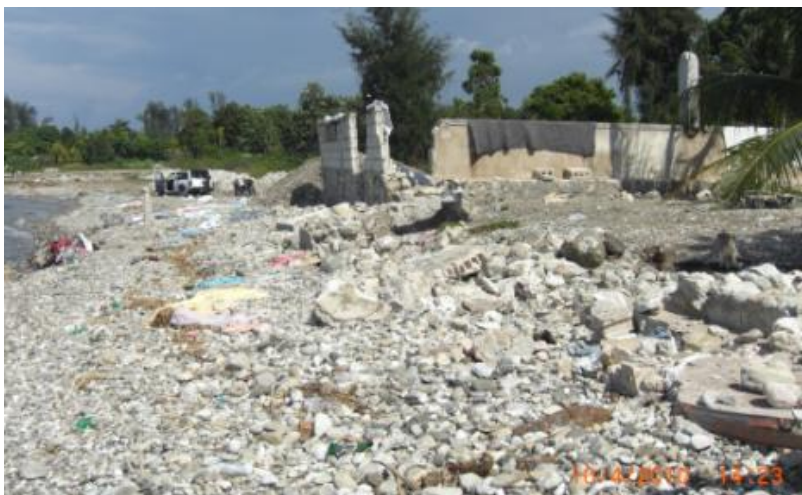
Figure 4.25: Collapsed building adjacent to laterally spreading ground

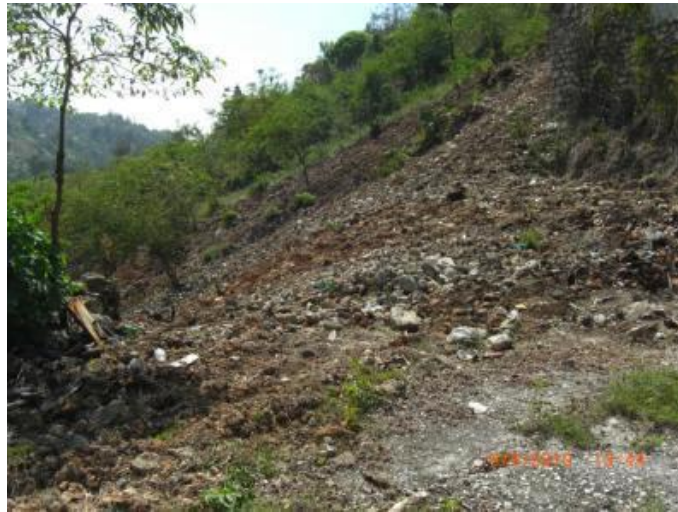
The EEFIT team also visited the hills close to Pétionville. There was evidence of some substantial landslides in this region following the earthquake. An example of one such landslide is presented in Figure 5.4. This landslide occurred downslope of a building that was protected by a retaining wall. The building itself and the retaining wall remained undamaged. It appeared that the landslide involved only

the top soil but not the deeper layers of soil and rock. However the total volume of soil that suffered slipping was quite substantial and is estimated to be a few thousand cubic meters.

Figure 5.4: Landslide in the hills close to Pétionville

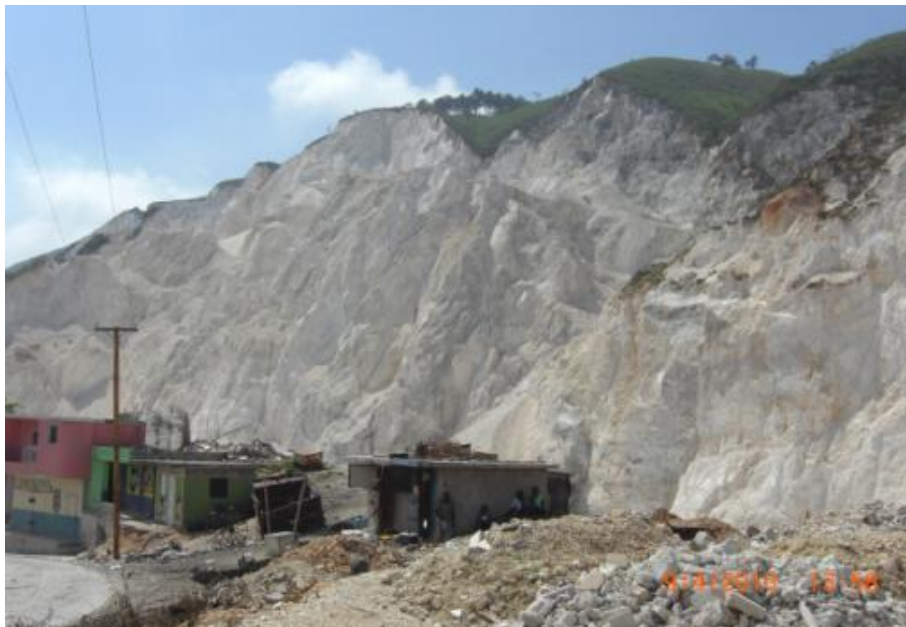
Figure 5.5: A large sand quarry near Pétionville

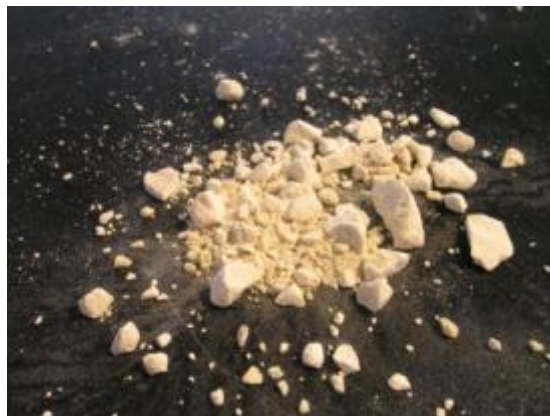
Samples of the soil were obtained from the sand quarry described above. A close-up view of the soil is presented in Figure 5.7. The Figure shows lumpy sand that is weakly cemented and is readily crushable by hand. Given this material is used in most of the constructions in and around Port-au-Prince and other cities in Haiti, it is interesting to investigate it further. The normal practice observed by the EEFIT team during the rebuilding activities currently going on in Haiti is to mix this material with cement and use it as mortar or concrete.

Figure 5.7: A close-up view of the soil from the sand quarry

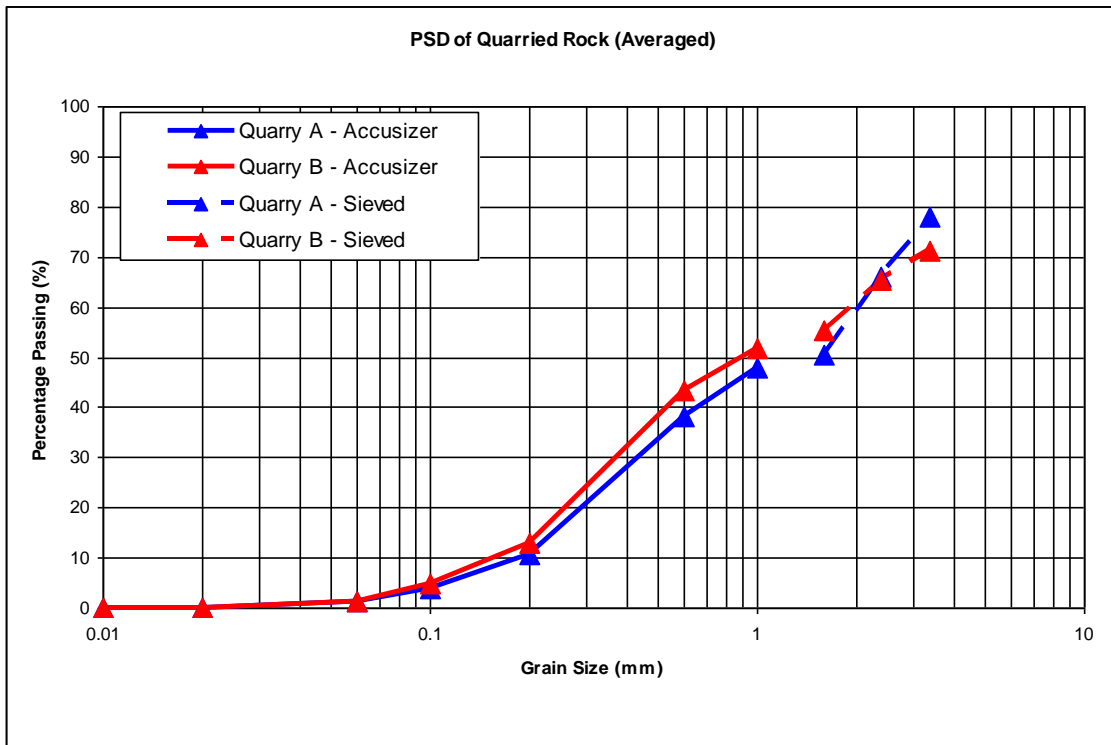
Figure 5.8: Particle size distribution curves of soil recovered from the sand quarries

In Figure 5.8 it seems that two samples from different sand quarries provide very similar particle size distribution curves. The material has particle sizes between 0.05 mm to 0.6 mm and therefore has fine to coarse sand particles. There were also few large sized particles of 2 mm to 4 mm. Both methods of analyses i.e. the sieve analysis and the optical accuser analysis gave almost identical results for both the samples investigated.

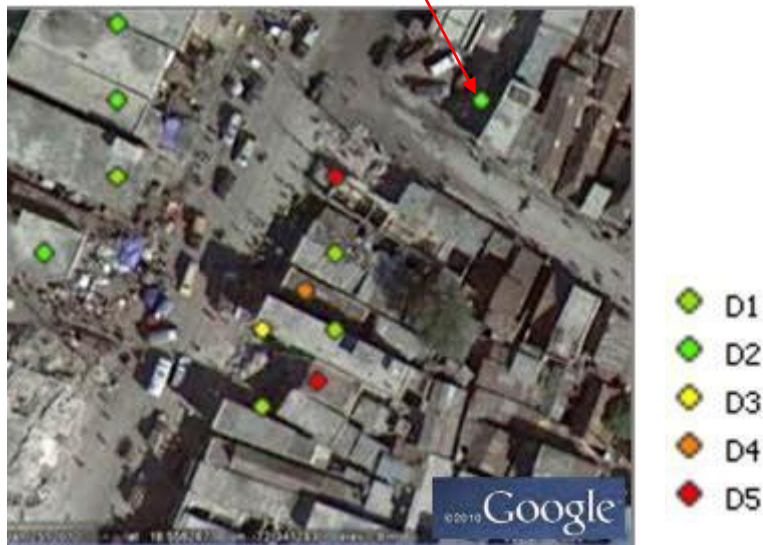
Figure 6.9: The buildings and their damage grades assigned by the EEFIT team.

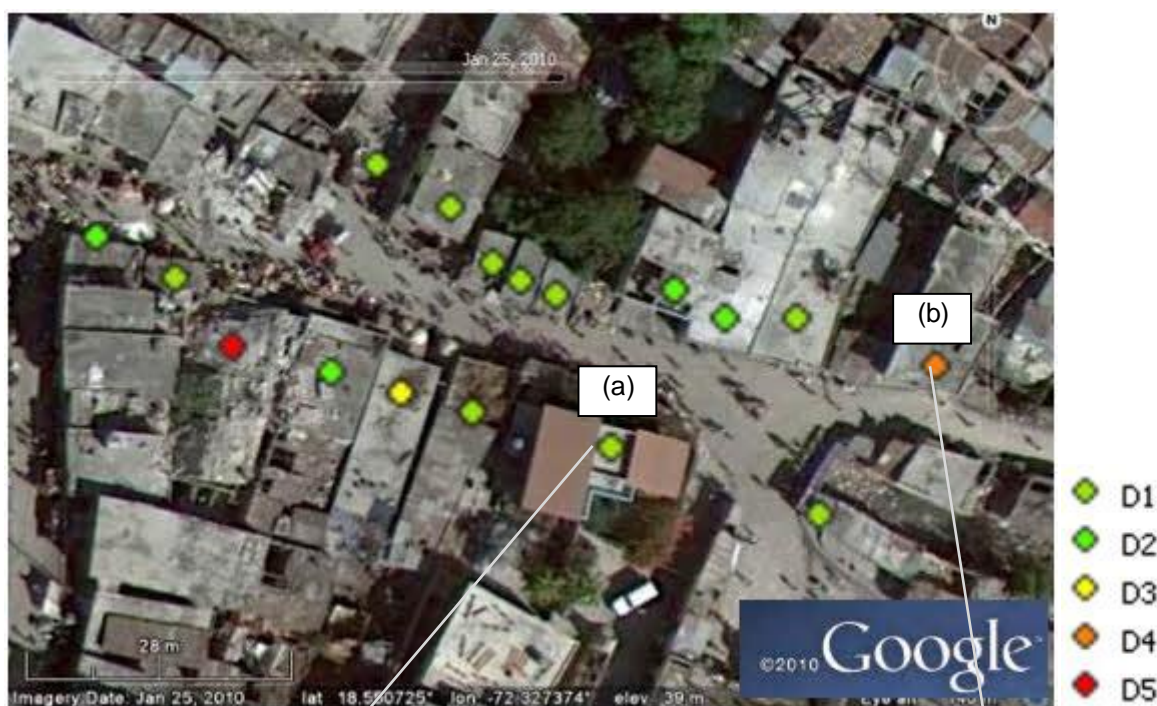
Figure 6.10: Overview of Location 3 in Google Earth and the EEFIT assessment results.

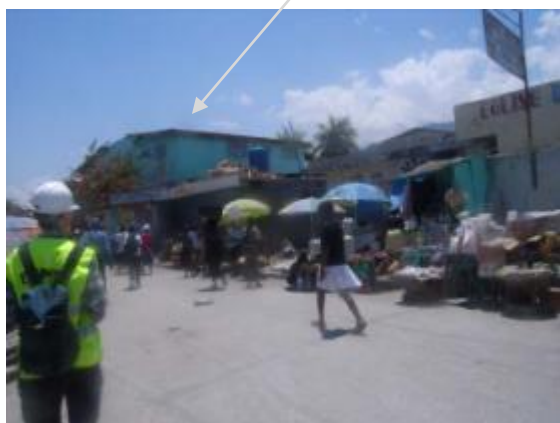
Figure 6.11: Ground view of building (a)

Building (a) is a good example of where it is difficult to see from a vertical aerial photograph whether it is one building or two. Figure 6.11 shows that it is one building. Building (b) was assessed as D4 by the EEFIT team; however, the damage (fall out of the brick infill wall) is not visible in a vertical photograph. Table 6.6 shows the breakdown of the damage grades assigned to the buildings in location 3.

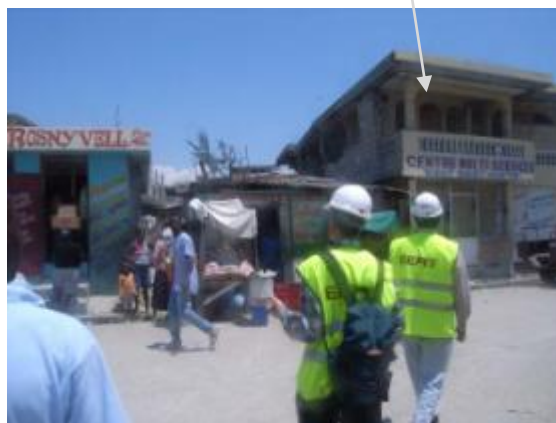
Figure 6.12: Ground view of building (b)

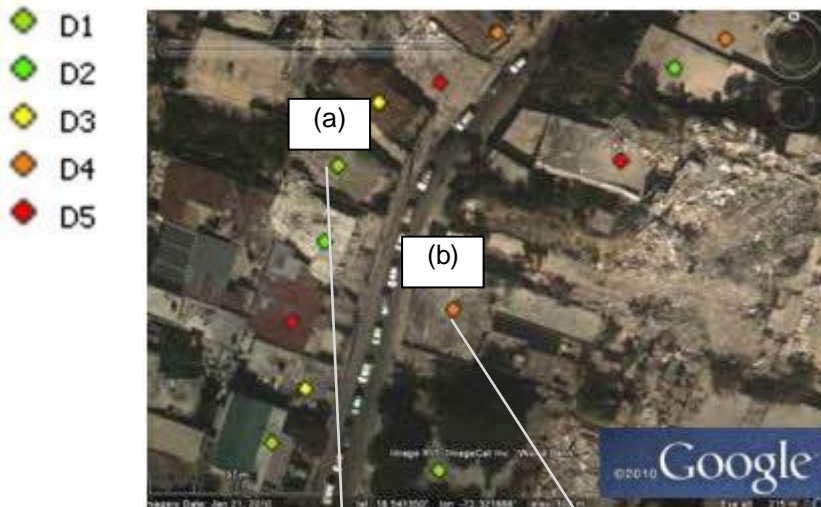
Figure 6.13: EEFIT surveyed buildings in Location 9 and the EEFIT damage grades.

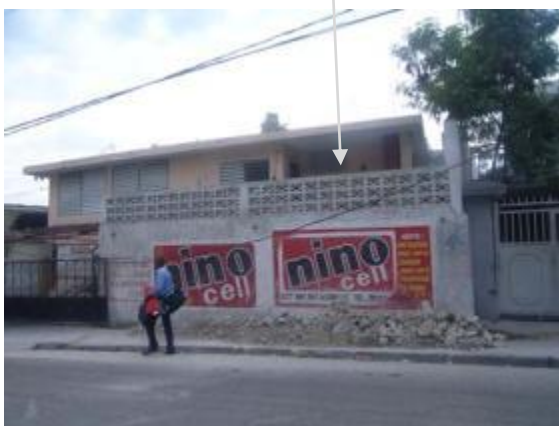
The EEFIT team was only able to look at building 9-1 in Figure 6.15 from the street due to the fact that the gate was locked. The façade seen from the street, despite having some vertical cracks, seemed to suggest minimal damage, hence a damage level of D2 was assigned. However both the Pictometry and GEO-CAN assessments assigned D4, possibly due to the amount of debris seen on the roof towards the back of the building. The opposite has occurred with building 9-19, where in the satellite image the building looks intact but when viewed from the ground the building is obviously heavily damaged (Figure 6.16). Table 6.7 shows the breakdown of the damage grades assigned to the buildings in location 3.

Figure 6.14: Building (a) which looks intact from the outside. EEFIT team did not have access to the premise. The aerial photo of the same building in Figure 6.13 shows some disturbance on the roof. Both Pictometry and GEO-CAN assigned D4.

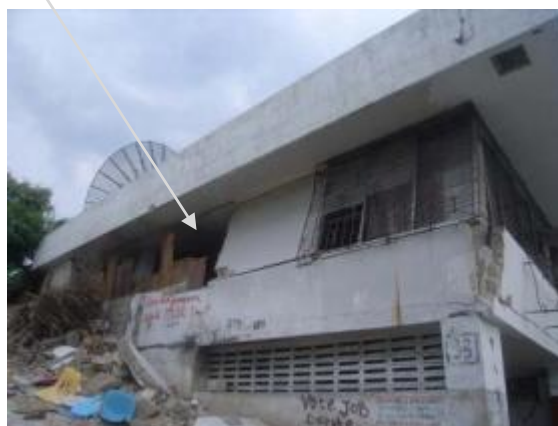
Figure 6.15: Building (b) which was assigned D4 by EEFIT. The same building looks intact in the aerial photograph in Figure 6.13. Pictometry and GEO-CAN assigned D1 and D0, respectively.

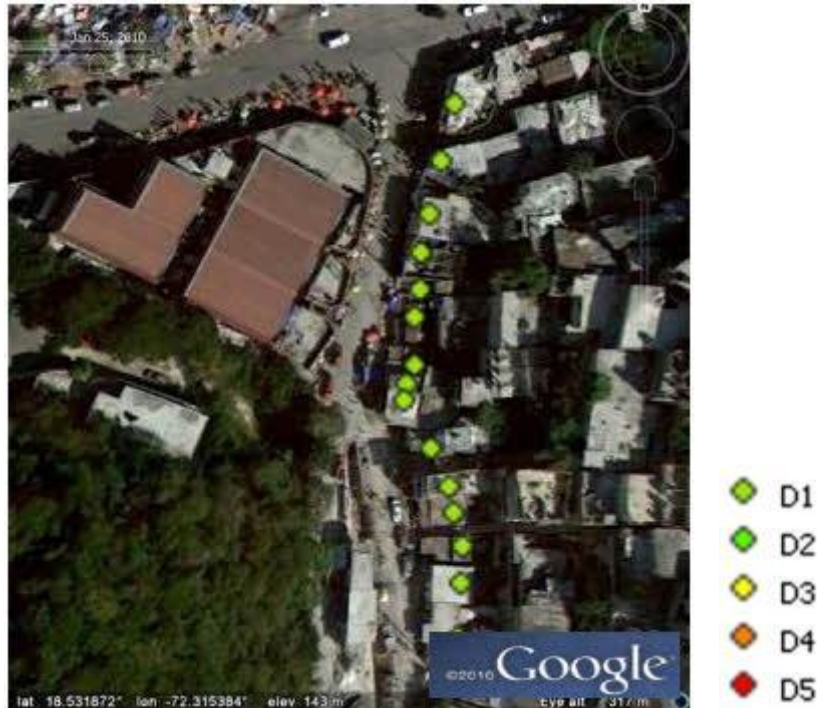
Figure 6.16: Overview of location 17 where all buildings were assigned D1 by the EEFIT team.

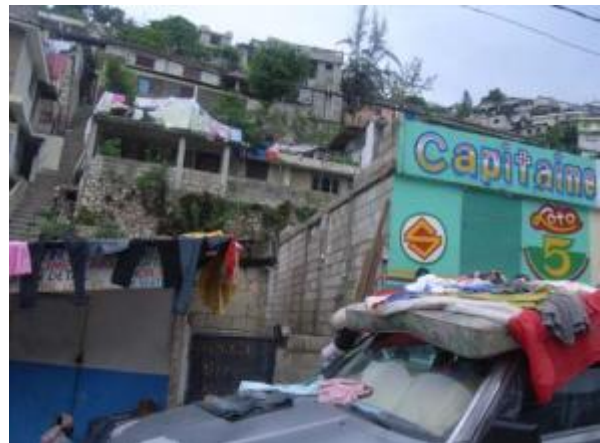
Figure 6.18: Buildings almost intact in location 17, although built on a steep slope.

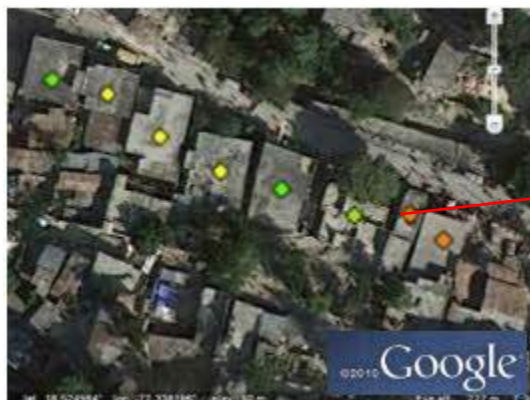
Location 22 is situated on the foot of the hills on the south edge of Port-au-Prince. The plot size of the residential buildings is on average smaller than location 9 but larger than location 17. None of the buildings seen by the EEFIT team had collapsed completely in this location (Figure 6.20). There were a few buildings that were difficult to assign a single damage grade, particularly the building seen in Figure 6.21. All buildings surveyed in location 22 are reinforced concrete.

Figure 6.20: Overview of location 22 and the EEFIT damage grades.

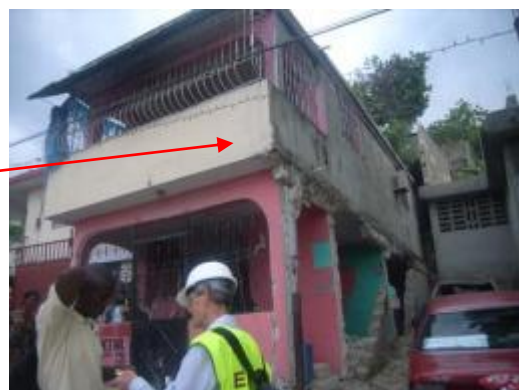
Figure 6.21: Building with serious damage to the infill wall on the ground floor.

The building in Figure 6.21 was originally assigned D4 in the field and has subsequently being downgraded by half point to 3.5. This building demonstrates the difficulty of assigning a single damage grade.

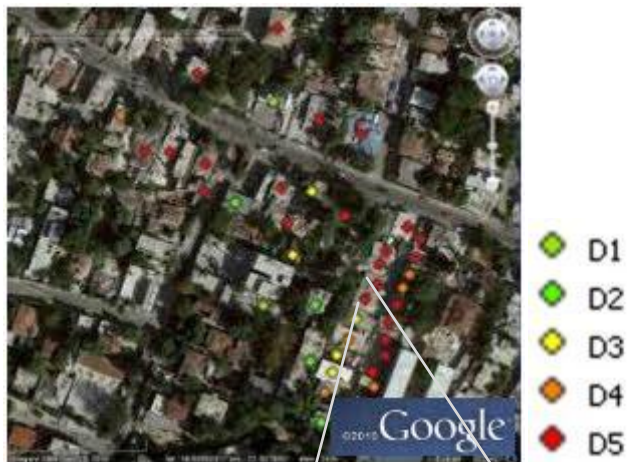
Figure 6.25: Location 41 overview

Location 41 is a middle class residential area with generally large houses. EEFIT team focused on one side street where many soft storey collapses were observed (Figure 6.25). Due to the focus on residential buildings, the team surveyed 41 buildings in this location, which is by far the largest sample size among the locations. The soft storey buildings were mostly not captured by the remote damage assessment, and prove to be the most difficult in identifying using satellite imagery and vertical aerial photographs. It is not clear as to why so many buildings had soft storey on this one street. Heavy damage was also seen in the neighbouring streets. Two traditional timber frame buildings described in a later Section (Section 7.5.2) were in this location.

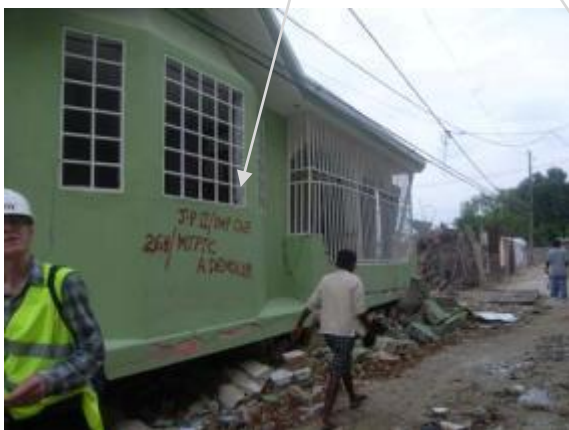
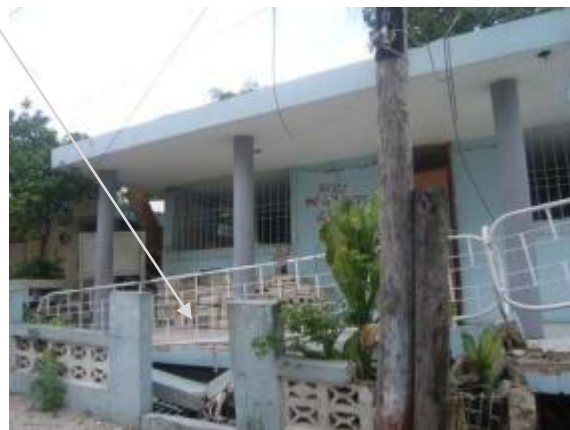
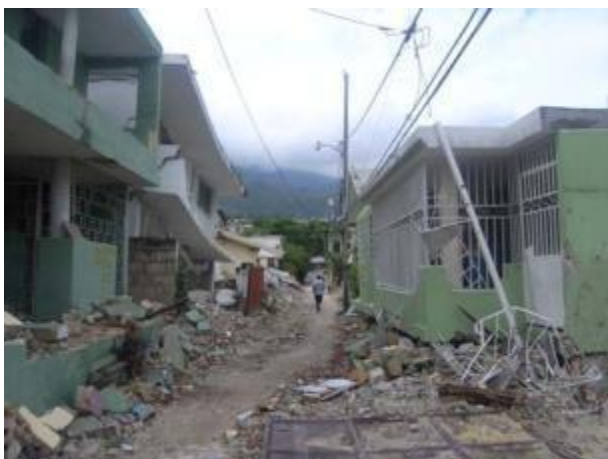
Figure 6.26: (top left, a) Building (i) with soft storey collapse. The soft storey was nearly missed even from the ground. b) Next to building (i) is another soft storey building (ii). (c) Street view showing the many heavily damaged buildings in location 41. View angle: north-east to south-west.

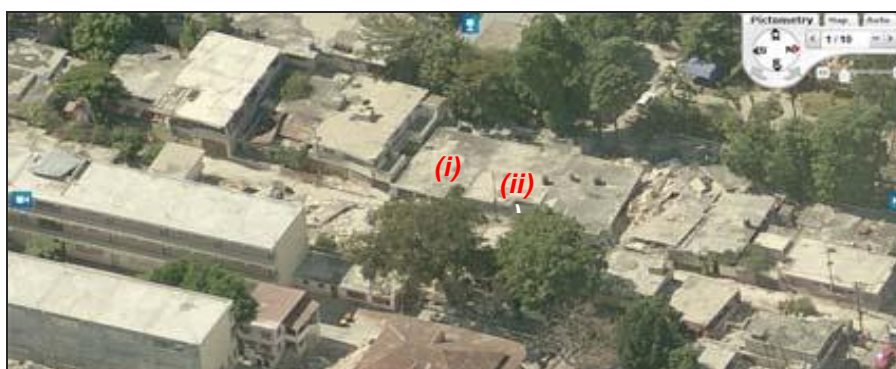
Figure 6.27: Pictometry image of part of location 41

The heavily damaged buildings on this street were mostly not identified either by GEO-CAN or Pictometry. The view of this street using Pictometry is shown in Figure 6.27 where the soft storey buildings (i) and (ii) in Figure 6.26 are marked. Table 6.11 shows the breakdown of the damage grades assigned to the buildings in location 41.

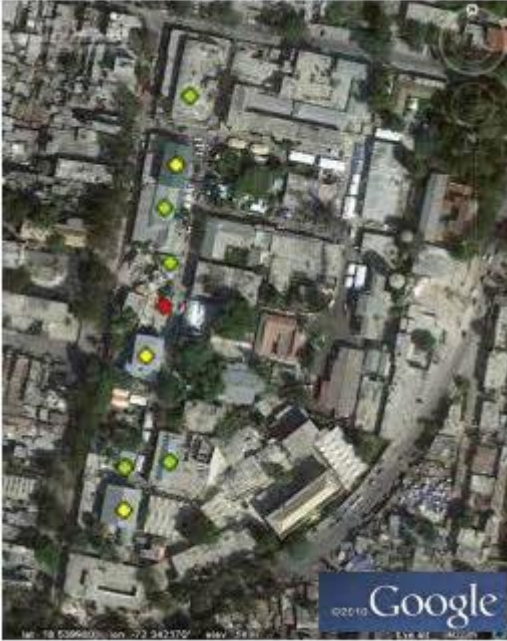
Figure 6.28: Overview of the buildings in location 55, surveyed by the EEFIT team.

Location 55 is the Port-au-Prince General Hospital. The complex consists of engineered buildings (Figure 6.28). One of the dormitories for student nurses had completely collapsed (D5: red dot in Figure 6.28), unfortunately resulting in a considerable number of fatalities. Some buildings were unsafe to be used; hence, temporary tents were erected outside these facilities where the patients were treated outdoors (Figure 6.29). Table 6.12 shows the breakdown of the damage grades assigned to the buildings in location 55.

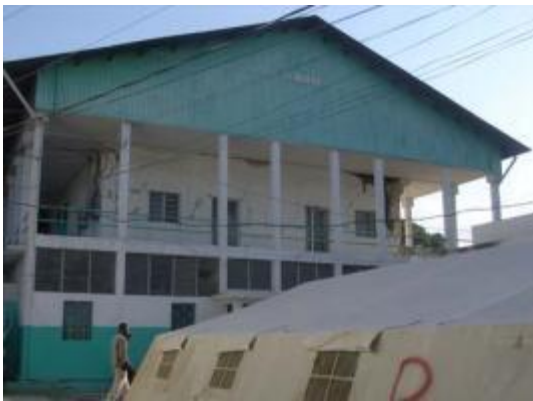
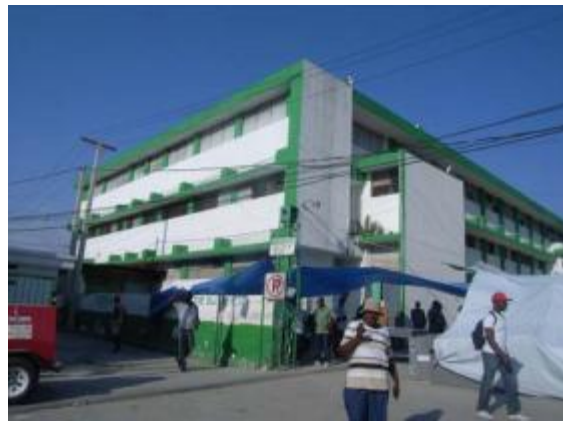
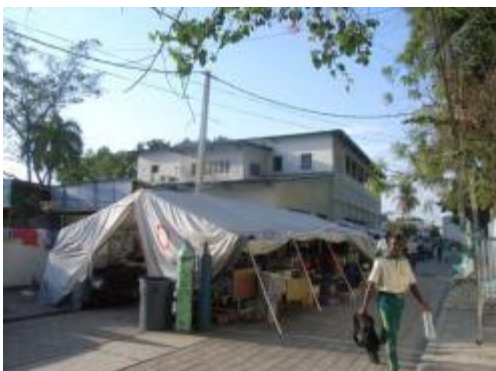
Figure 6.29: (a) A D3 building. Damage to the walls could not be seen even in Pictometry. (b) One of the main hospital buildings with no apparent damage. EEFIT team inspected the building from the inside. (c) The tent clinics erected outside the damaged buildings.

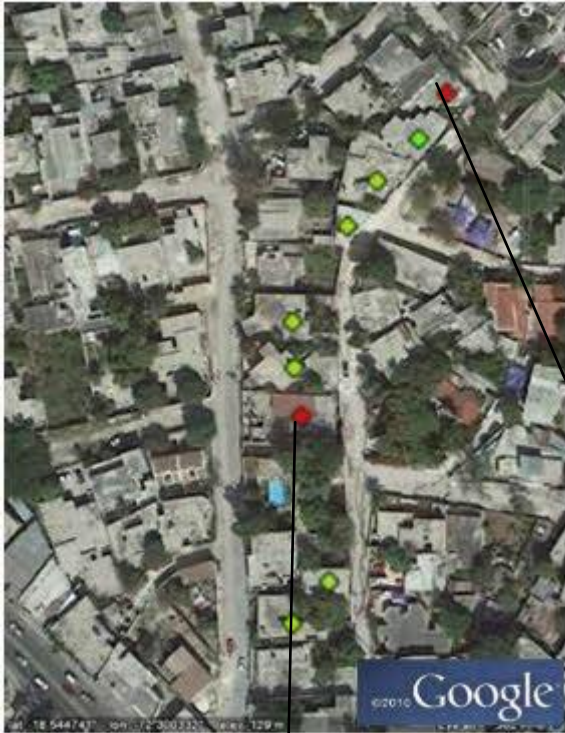
Figure 6.30: Overview of the buildings surveyed in location 61.

Location 61 is on the north side of the main road in Delmas that runs from west to east through Port-au-Prince (Figure 6.30). The area is a low density residential area, and the plots in this location are generous. According to one of the residents 8-10 people typically live in one property. Many of the houses have a wall over 2m high which restricted the view of the buildings from the street.

One building under construction had heavy damage, which was captured by the Pictometry assessment as well and assigned D5 in both cases. A soft storey building assigned D5 by the EEFIT team was assessed as D4 in Pictometry. Both buildings were missed by GEO-CAN. Table 6.13 shows the breakdown of the damage grades assigned to the buildings in location 61.

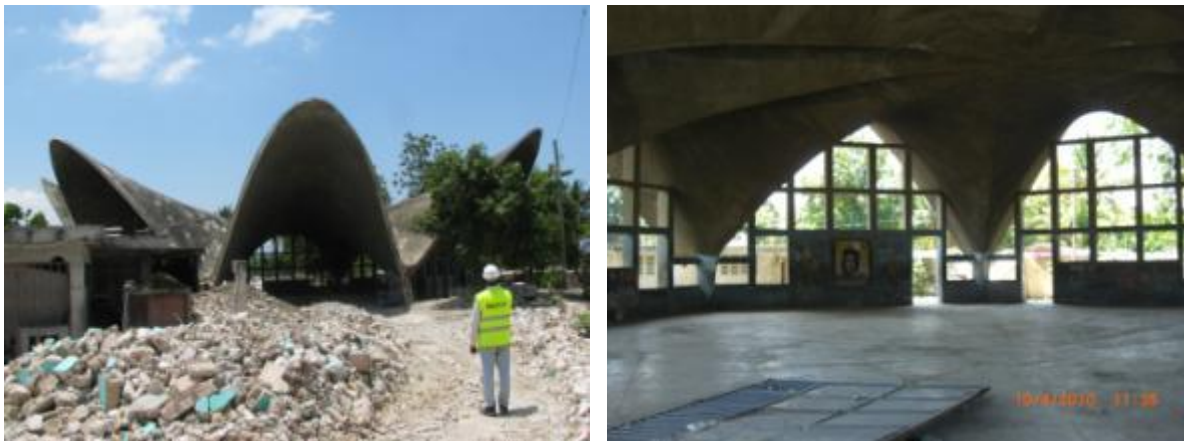
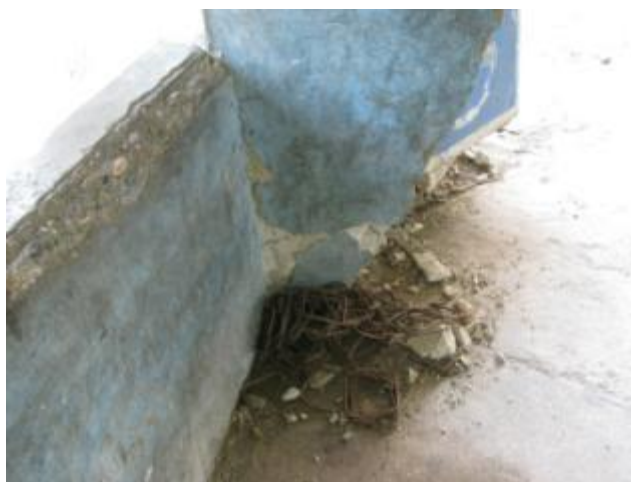
Figure 7.1: Market building, Léogane

The team inspected a curious reinforced concrete folded plate roof structure in Léogane (Figure 7.1), which was reported to have been built as a market in the 'Papa Doc' era and therefore presumably predates the dictator's death in 1971. There was some spalling of surface concrete at one of the support points (Figure 7.1, bottom photo) but no other signs of damage. The structure would probably have responded as a rigid body to the earthquake (unless soil flexibility was significant, which is a possibility) so this level of damage might make a rough estimate of the peak ground acceleration possible.

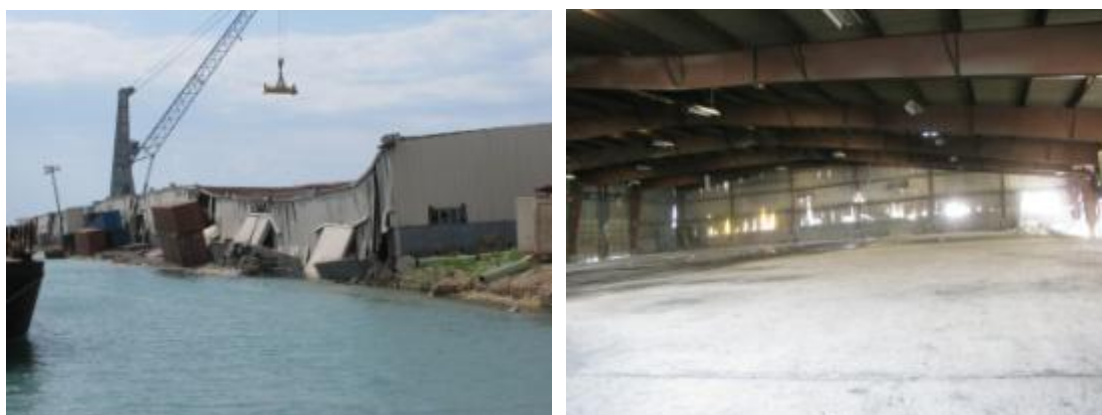
Figure 7.2: Port-au-Prince main port warehouse

Apart from the occasional steel joist or column seen in predominantly concrete or masonry buildings, the only significant steel frame structures that the team encountered were a pair of large warehouses on the reclamation behind the failed wharf in Port-au-Prince main harbour; the wharf failure is discussed in Section 4.3. Figure 7.2 shows internal and external views of the eastern warehouse, which was approximately 250m long and 50m wide. The building envelope was supported by single span steel portal frames at 30m centres, clad with light weight corrugated steel cladding.

The eastern warehouse was inspected internally. The failure of the wharf on which the warehouse was built resulted in large settlements of some of the southern (port side) foundations of the portals, in the order of 1 to 2 metres, and lateral displacements of up to 0.7m (Figure 7.3) . Figure 7.4 shows that this resulted in extensive buckling of the roof beams, but remarkably the structure had been able to accommodate these deformations without collapse. It is likely that the foundation settlements occurred a few minutes after the main shaking had ceased, because the liquefaction induced ground failure would have taken this length of time to develop. Therefore, ground shaking and large ground deformation would probably not have loaded the structure simultaneously. There was no evidence of any ground shaking damage to the building, which probably would have survived the earthquake essentially undamaged had there been no ground failure.
