THE HAITI EARTHQUAKE OF 12 JANUARY 2010

A FIELD REPORT BY EEFIT

Edmund Booth, Edmund Booth Consulting Engineer.

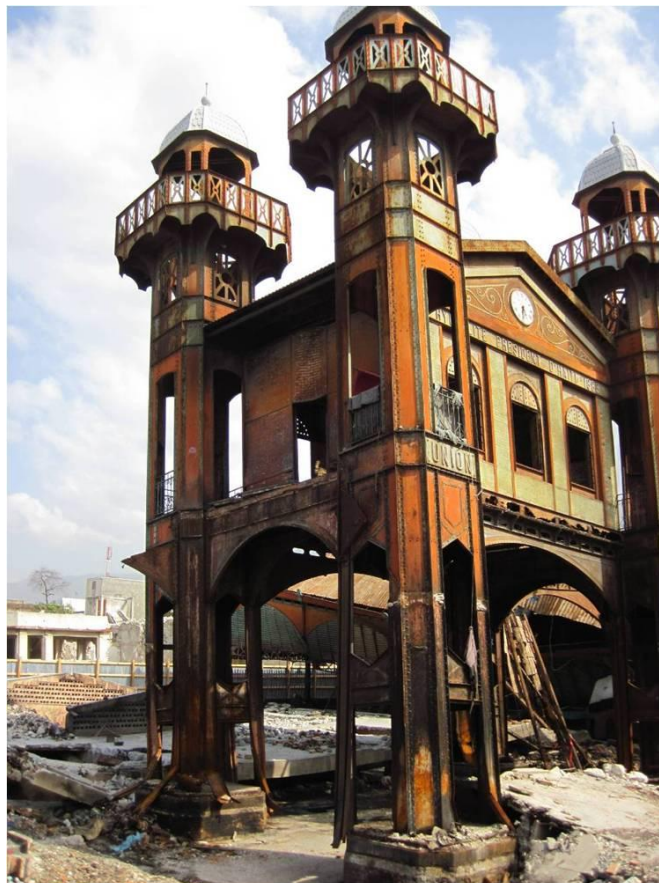
Figure 7.8: The clock tower

Standing centrally between the two markets is a curious ornate clock tower (Figure 7.8), fabricated from riveted 6mm thick wrought iron plate. There are four corner columns, each surmounted by a gallery, and together supporting a central suspended chamber. It seems that the clock tower was originally intended for Cairo railway station, but that order was cancelled, and it became Port-au-Prince's iconic building instead.

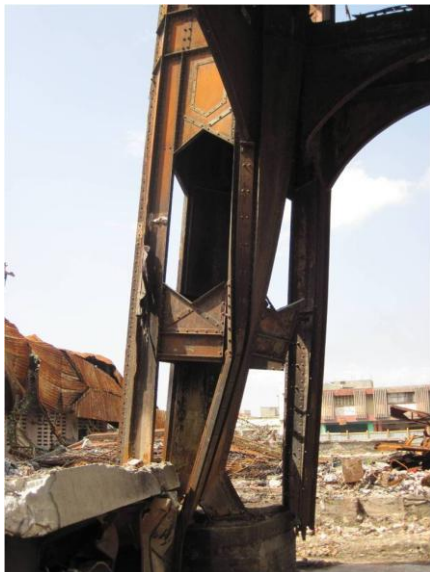
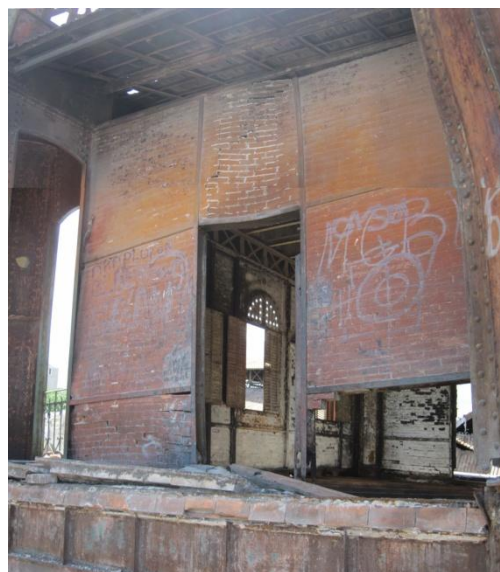
Figure 7.12: The clock tower

The clock tower suffered severe damage to the bases of its four columns, which split at the seams and became partially detached from the baseplates, causing significant shortening (Figure 7.12a). This led to a pronounced tilt of the tower, but (as can be seen from Figure 7.8) it remained stable. Infill masonry in spandrel panels at high level also cracked under high shear deformations, but remarkably remained mainly in place, possibly as a consequence of the use of lime mortars (Figure 7.12b). A fire which broke out after the earthquake is also thought to have damaged the clock tower.

(a) Column base

(b) Performance of infill masonry spandrels
(composite of two photos)

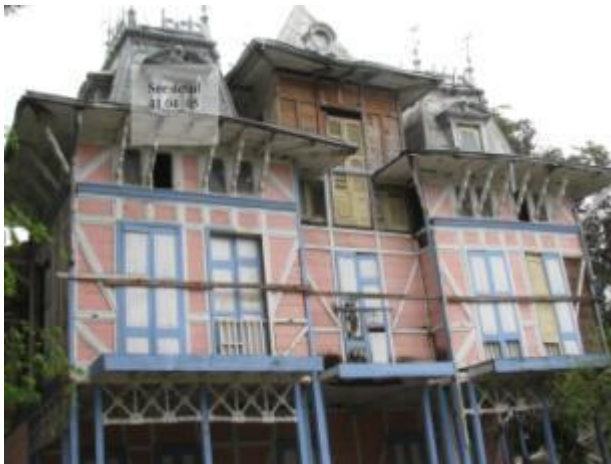
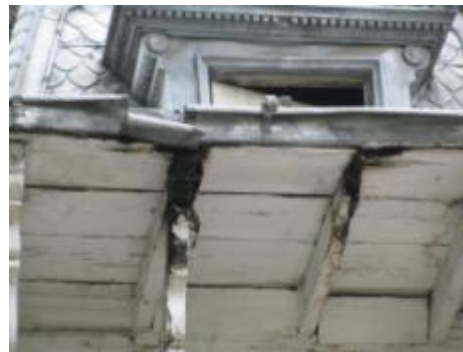
Figure 7.14: 'Gingerbread house' in Port-au-Prince

A number of two and three storey timber frame buildings were observed in Port-au-Prince and Léogane. They date from the end of the nineteenth or early twentieth century and are dubbed 'gingerbread houses' (Figure 7.14). In 1925, new timber frame construction is understood to have been banned in Port-au-Prince to prevent fire, so presumably this gives their latest date of construction. Although some of the buildings were poorly maintained, none of the fifteen or so gingerbread houses which the EEFIT team saw had collapsed. However, there are reports that some of the smaller houses were completely destroyed and many of the larger houses suffered serious structural damage including some that lost facades and walls.

(b) Detail showing poor maintenance

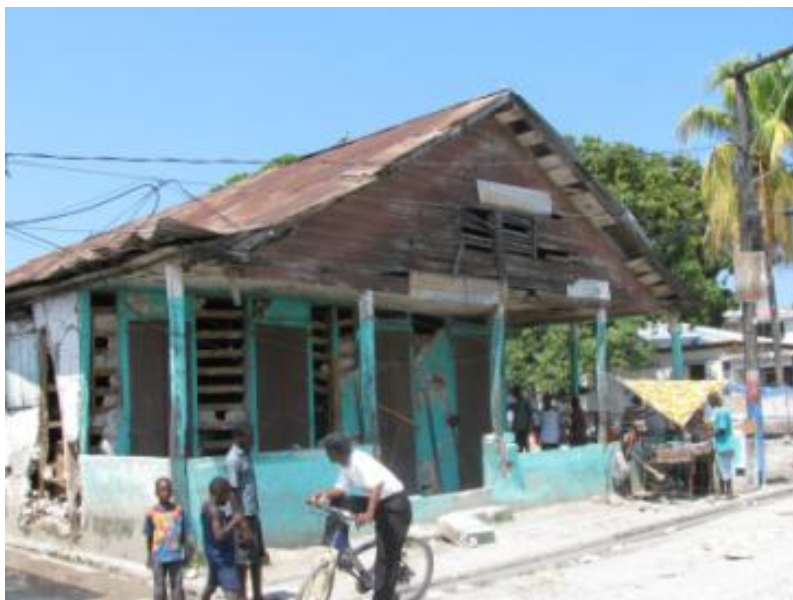
Figure 7.15: Single storey timber and masonry (colombage) building in Léogane

Figure 7.15 shows a single storey timber and masonry building in the main square of Léogane in poor condition, which survived, despite being close to two or three storey concrete and masonry buildings which had collapsed. This is a form of construction known as 'colombage', consisting of timber frame with infill masonry walls. The good tensile strength of timber and its favourable strength to mass ratio are likely to have been contributory factors in its survival; it would be interesting to know if local variations in the intensity and frequency content of the ground motions also played a part. Unlike Port-au-Prince, where dramatic local variations in ground motion were found at geological boundaries (Section 8.4), Léogane is in area which is essentially flat and has no obvious signs of variations in the surface geology.

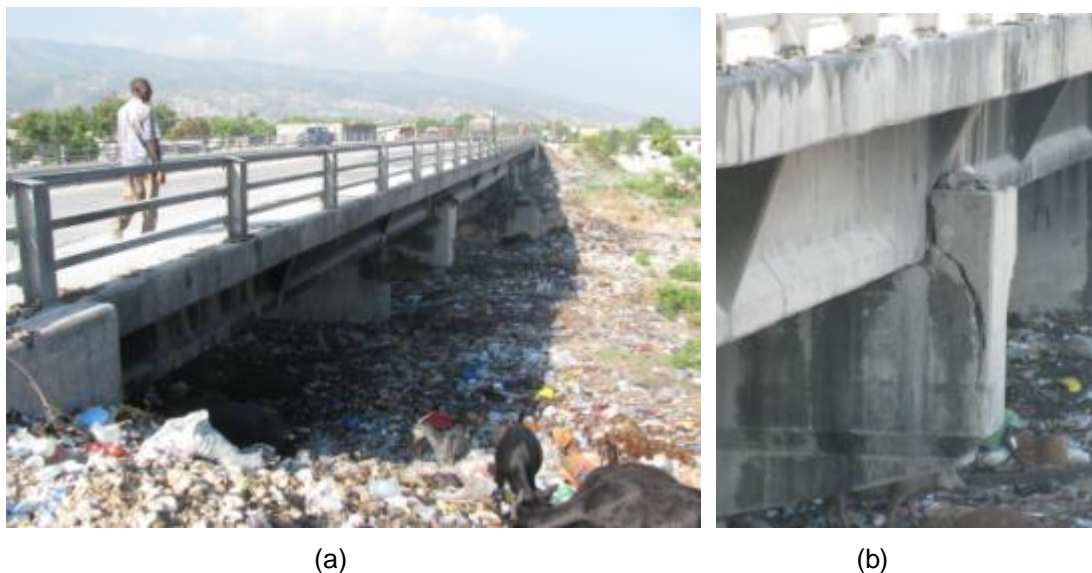
Figure 7.16: Bridge at Lemartin west of Port-au-Prince, near Carrefour

During their journey between Port-au-Prince and Grand Goâve (Figure 3.1), the team observed four concrete river bridges. They were all of recent concrete construction, built to a high standard, with one or two river piers. The deck spans were between 20m and 30m, and each span was simple supported at each end, with expansion joints over the piers and abutments (Figure 7.16).

One of the bridges was impassable, but had been rendered so by extreme river flow in a hurricane a few years earlier. The three other bridges were open to traffic and it appeared that no significant post-earthquake repairs had been carried out. The main structural damage, which occurred in two of the three bridges, was to the lateral restraining elements at the supports (Figure 7.16b). There were no significant settlements either relatively between deck spans, or of the fill at approach abutments.

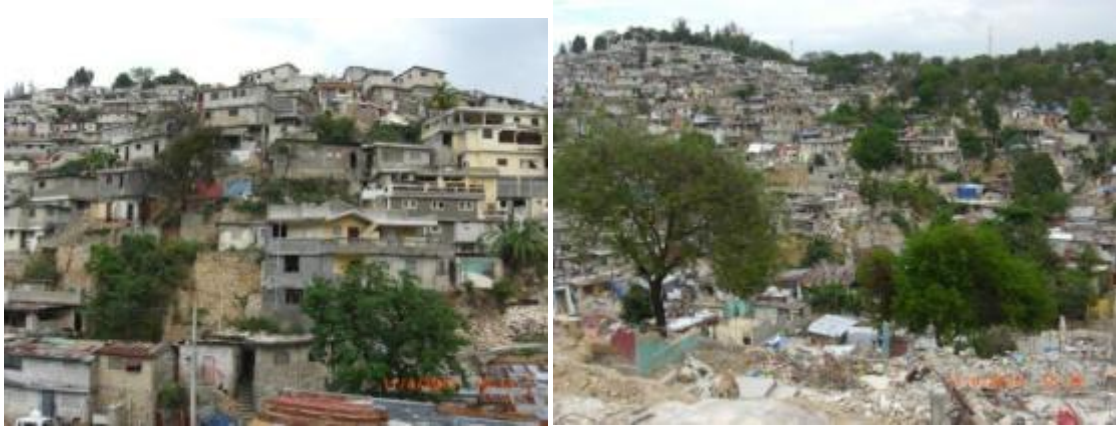
A striking example of damage clustering was found near location L17 of the EEFIT survey in the Canapé Vert district of Port-au-Prince (Section 6.5.6). Heavy damage occurred only a few hundred meters from a site on the neighbouring hill, where buildings performed very well with only minor damage (Figure 8.4). Even the dry stone retaining walls did not show any signs of distress as seen in Figure 8.4(a).

(a) Light damage

(b) Heavy damage

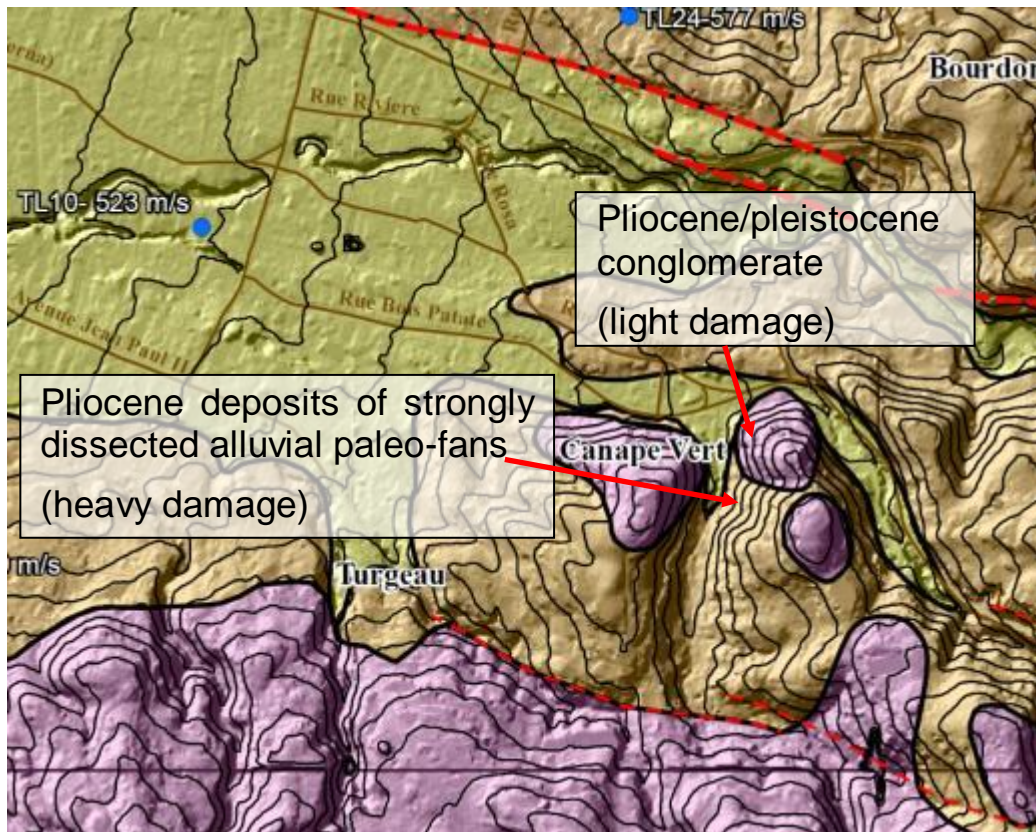
Figure 8.5: Geological boundaries in Canapé Vert (adapted detail from Bachuber *et al*, 2010)

There was no obvious difference in construction type or quality between the two sites, and no immediately clear differences between topology and surface geology; both were steep and rocky. However, it appears that the boundary between light and heavy damage, which was dramatic, occurred on the junction between two geological rock types (Figure 8.5). The two rock types were:

Pliocene deposits along the edge of mountains forming a complex of strongly dissected alluvial paleo-fans (heavy damage).

A possible explanation based on the above differences in rock geology is that the differences in weathering patterns and/or differences in rock stiffnesses may have led to differences in wave propagation and topographic amplification at the two sites. This may have resulted in the vast differences in the damage patterns observed at the two sites.

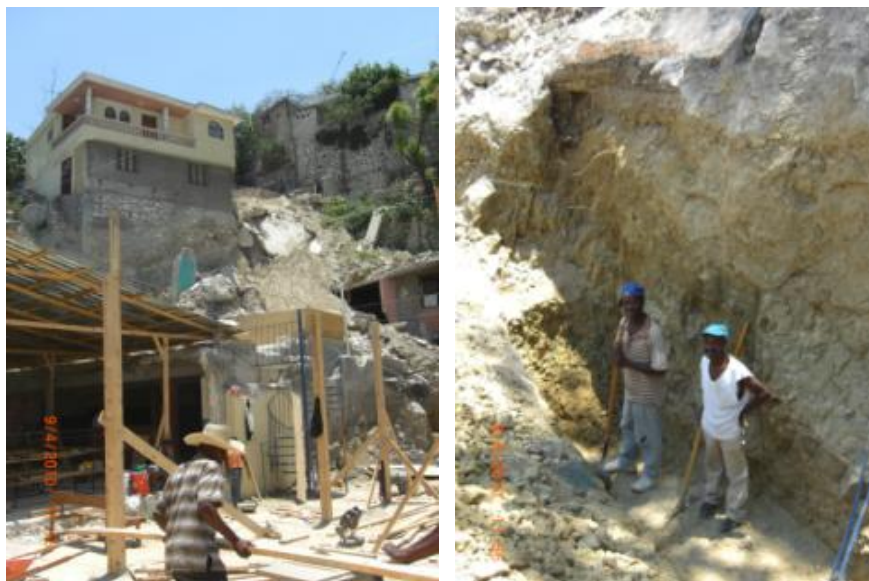
Figure 8.7: Site with soil failure causing building collapse in Delmas

Another example of a building that was located at the top a steep slope is presented in Figure 8.7. As seen in the Figure, part of the building has completely collapsed onto buildings at lower level. Another building next to it has survived and the retaining wall protecting this part only showed minor signs of distress. A foundation pit was being dug at this site as shown in Figure 8.7, showing silty clay soil. A soil sample was recovered from this pit by the EEFIT team and was analysed on return to the University of Cambridge using the optical Accusizer. The particle size distribution curve for this soil sample is presented in Figure 8.8.

(a) Overview of failure (b) Excavation near base of slope

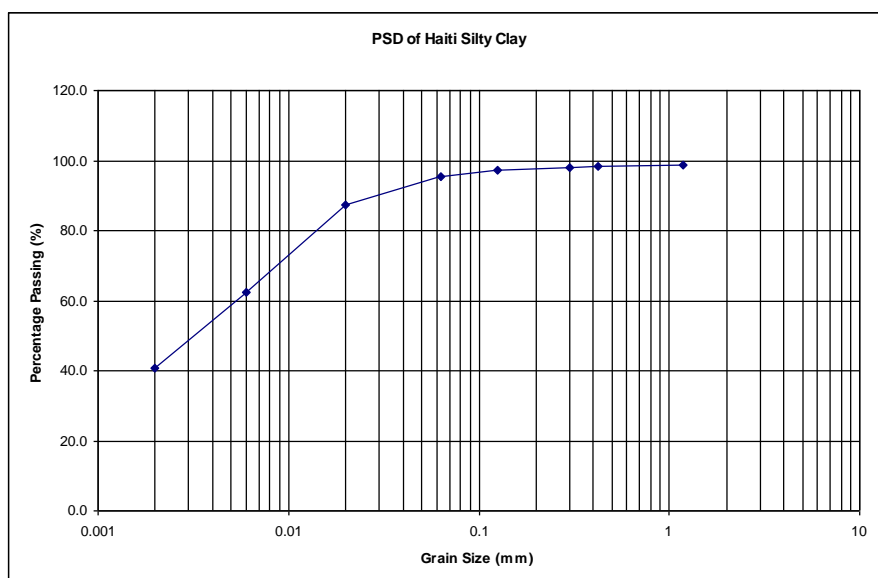
Figure 8.8: Particle size distribution curve of the clayey silt sample

The particle size distribution curve confirms the clayey silt nature of the soil at this site, with the maximum size of particles being about 0.6 mm and D50 size of the sample being about 0.003 mm. The nature of this soil and the steepness of the slope may have contributed to the amplification of ground accelerations felt by the building at the top of the slope.

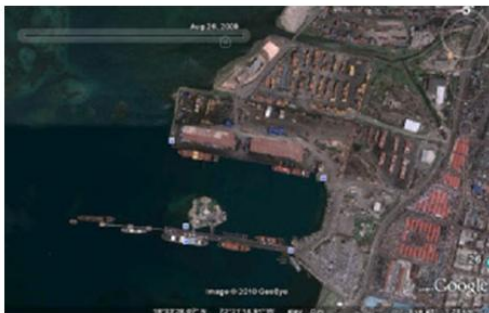
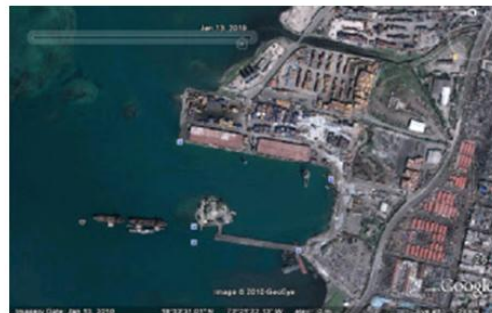
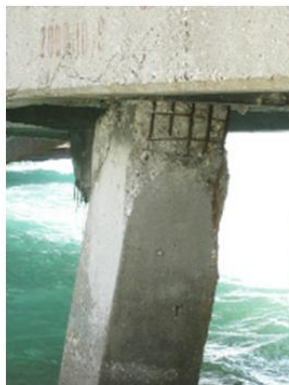
This pier had sections that collapsed due to liquefaction induced lateral spreading as seen in photo 3. The collapsed sections can be identified by comparing the pre and post earthquake satellite images shown in the photos below.

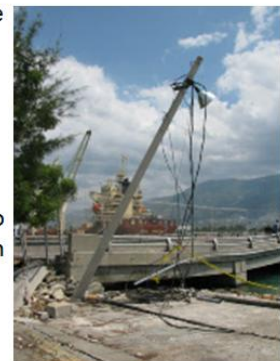
Close to the South pier there is an island that housed the security of port as seen in pre-eq satellite image. This island formed by fill material suffered excessive subsidence as seen in the photos of the bridge.

Also excessive lateral spreading of about 1m was also observed that caused damage to a jetty supported on piles with plastic hinging at the pile heads.

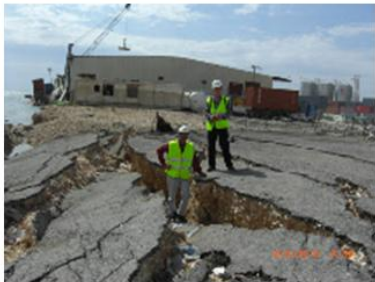
The lateral spreading at the entrance to the north pier which lost a complete wharf section was also inspected. This is illustrated in photos below.

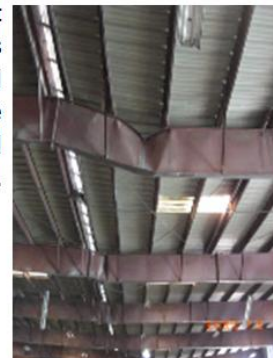
The liquefaction induced damage to the north pier had many interesting aspects, for example the case of a storage godown that suffered extensive damage as the portal frames supporting the roof underwent sway motion with local buckling of the main beams. Similarly there was the case of the storage silos located on a site where lateral spreading was observed, but did perform quite well. These will be discussed in the full EEFIT report.

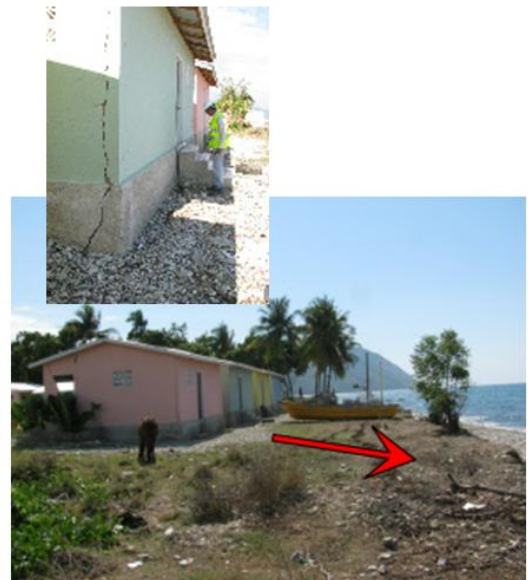
Lateral spreading has dragged forward the front of these buildings

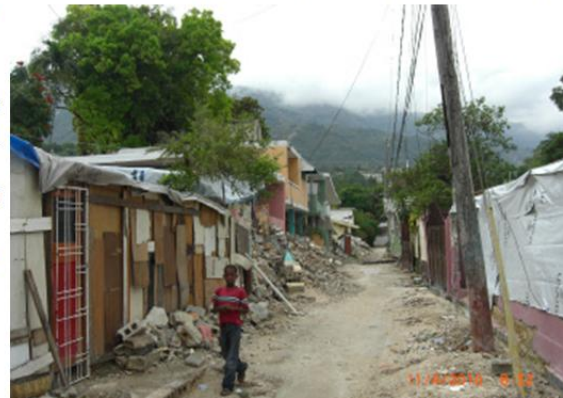
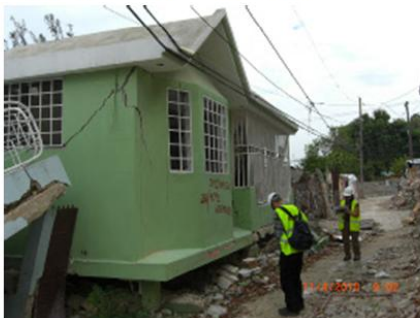
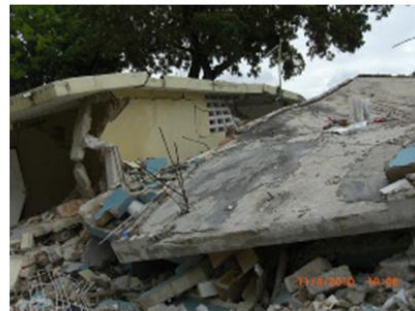
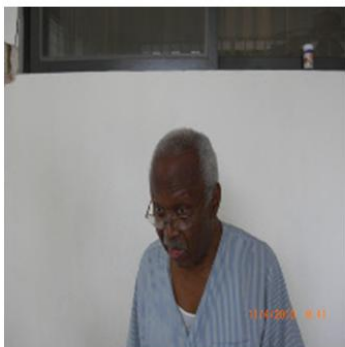
described as a leafy suburb of Port-au-Prince. The first street we conducted the survey was flat but we could see the mountains in the south directly behind. There were a lot of buildings that suffered total collapse (D5) or were very severely damaged (D4) in this area. We estimated that about 80% of the houses may fall in this category. The photos below show some of the failures.

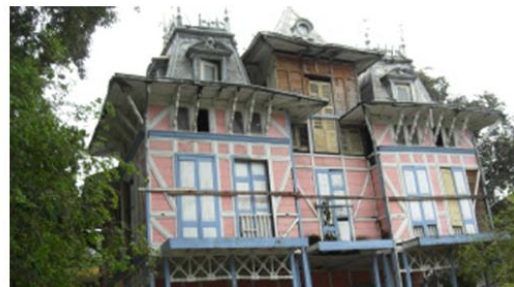
In this area there was an interesting historical structure – what we now term as the ‘ginger-bread’ houses. This structures is about 115 years old and was not in use since 1998. The house betrays the French architecture and the colonial past of Haiti, none the less a very beautiful building that is light, timber frame. A view of this house is seen in below. The structure was in a state of disrepair prior to the earthquake, and lost the back facing wall during the earthquake.

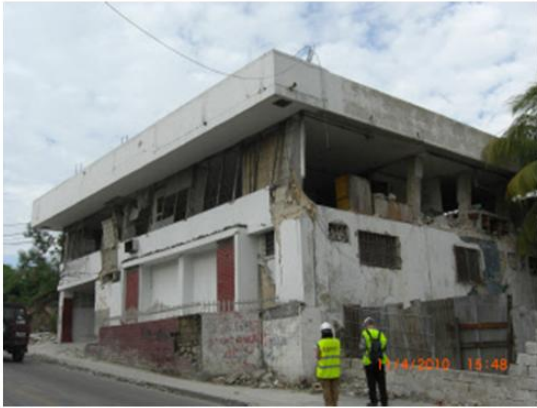
The team finished the day by surveying the area called Nazon (area 9). Again the damage in this area has been severe. Some structures should actually have collapsed but it seems they are up there with 'shear determination' to hold them up. An example of this is shown to the left.

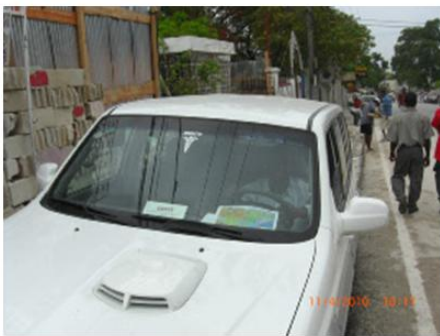
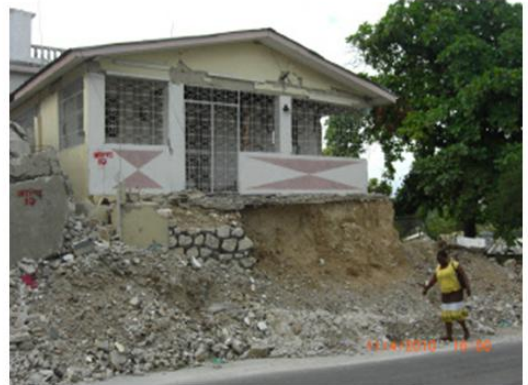
Others seem to hang on, although their survival seems to be totally 'baseless' from an engineering point of view as seen below.

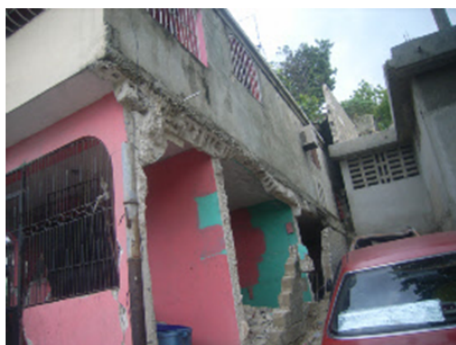
Next, we revisited [location 17](#), which is a location where we visited the day before. This time, we walked up the valley, where from one point onwards many of the building had collapsed due to ground failure whereas before that, there were hardly any damaged buildings. This phenomena intrigued us, therefore the revisit. We are still left with more questions than answers!
